Secure Home Inspections of NY, LLC

Client: Mary & John Smith
Address: 1234 Main St
City: Anytown, USA
Phone: 555-555-5555

Inspection Date: 7/14/2020
Inspector: John Mondello
NY Lic #16000055914
jpmondello@gmail.com

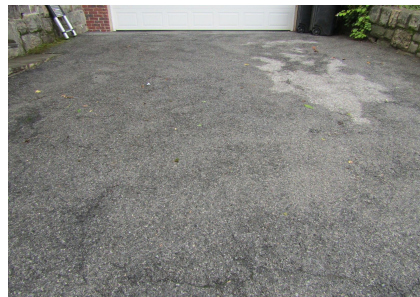
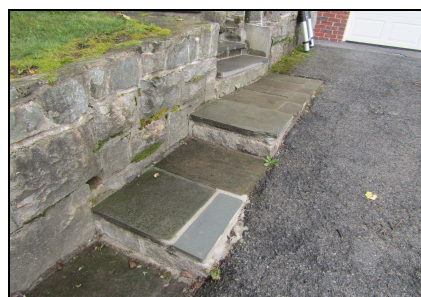
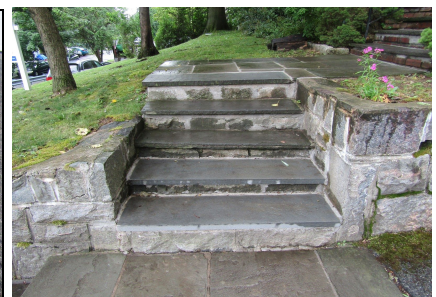
- ☐ The asphalt driveway had minor cracks; these should be monitored and repaired as necessary.
- ☐ The steps leading from the driveway to the front door are missing a railing - a safety hazard.
- ✓ A qualified person should install a **railing on the steps leading up to the front door.**

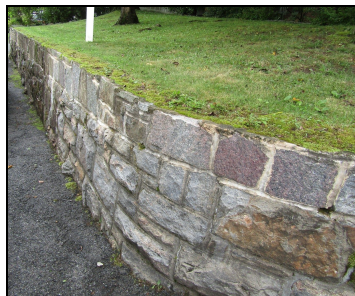
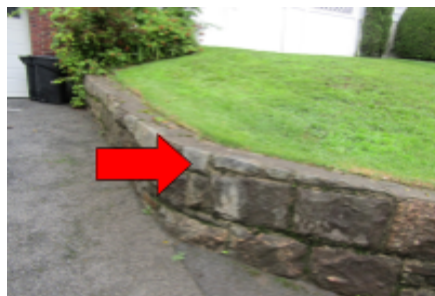
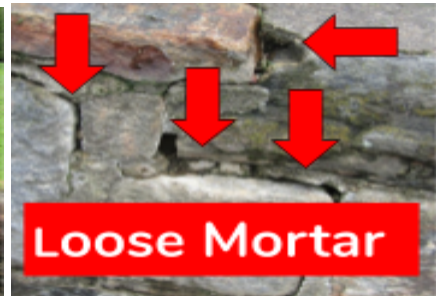
- ☐ **Retaining walls** were in serviceable condition, except in one area **bordering the driveway.**
- ✓ A qualified person should **replace the mortar in the retaining wall bordering the driveway.**

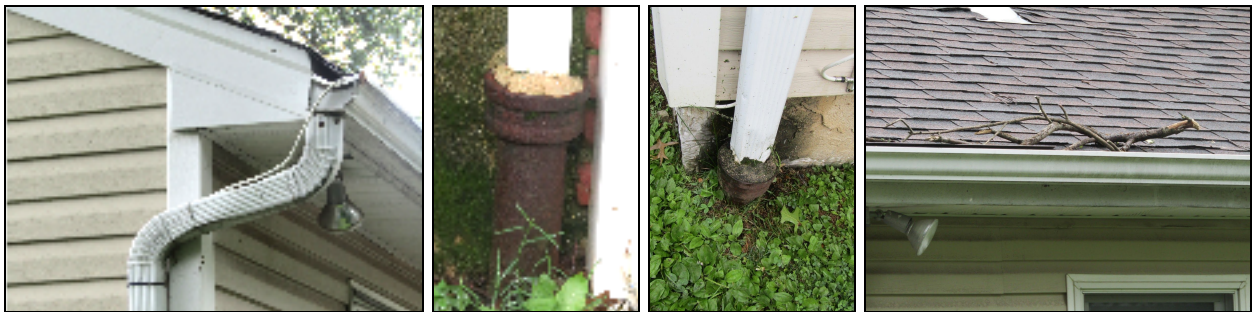
- ☐ **Shingles** covering the **front porch** were **older**; these should be monitored and repaired or replaced as needed.
- ☐ **Gutters** were generally in serviceable condition; they should be **cleaned at least twice a year**. Here are some tips on [gutter and downspout cleaning and repair](#).

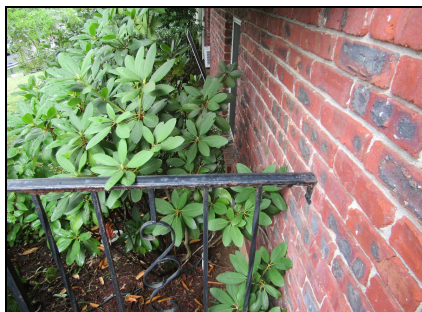
Shrubs too close to siding

- ☐ **Trees and vegetation** were too close to the **roof and siding in the front of the house, and the shed roof**. Roofs are susceptible to damage due to falling branches and limbs. In addition, the leaves from trees can clog your gutter system, allowing rainwater to accumulate and cause moisture damage to roofing and exterior siding.
- ✓ A qualified person should **trim trees and shrubs back** so that they are not in contact with the **roof, siding, gutters or the shed roof**.

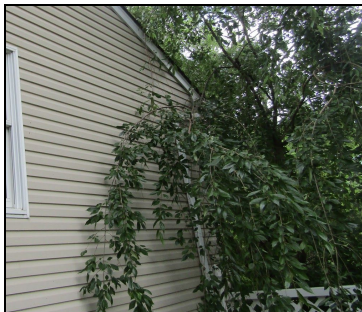
Branches too close to roof

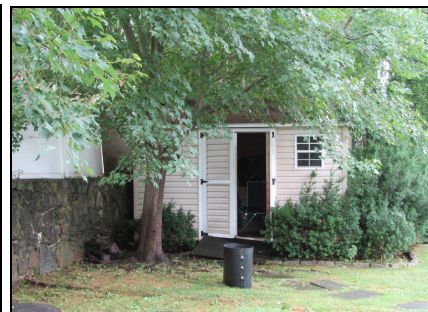
Branches cover shed roof

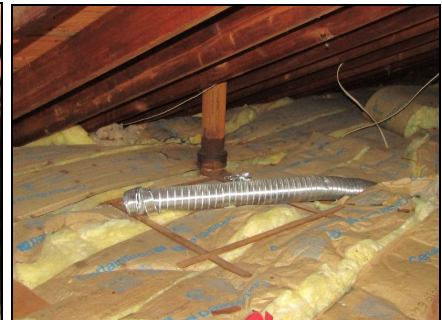
Bathroom Exhaust Vent Pipe

- ❑ Attic rafters and floors and roof decking were in serviceable condition;
- ❑ The [bathroom exhaust vent pipe](#) did not exhaust to the **outside**. This allows **excess moisture** from the bathroom, **especially in the winter**, to build up frost on the underside of the roof sheathing. Eventually this ice melts and **leaks onto the insulation and drywall ceiling**.
- ✓ A qualified person should repair or replace the [bathroom vent pipe](#) so that it vents to the outside.

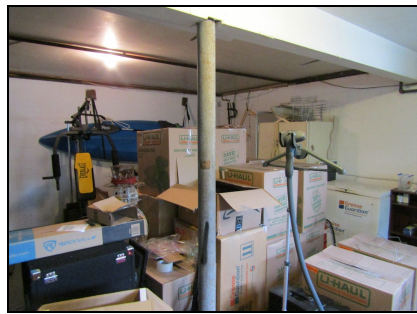
Interior Door

- ✓ The garage roof, walls, ceiling and floor were in acceptable condition. There was no evidence of moisture. The electric garage door was in serviceable condition, except that the garage door **did not auto-reverse when pressure was applied**.
- ✓ The interior garage door to the house **did not self-close**. This could allow car exhaust or flames from a garage fire to enter the house.
- ✓ A qualified person should repair or replace the interior garage door to the house as needed, to make it **self-closing**.

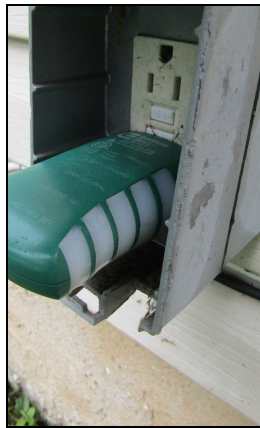
Defective Ext. GFCI

- ☐ A representative sampling of **standard and GFCI outlets** worked when tested. GFCI outlets protect against electrical shock or fire when connecting appliances that are close to sources of water.
- ☐ The **laundry area was missing GFCI outlets** (pls see the Laundry Section, P. 12).
- ☐ One **exterior GFCI outlet** was defective.
- ✓ A licensed electrician should repair or replace the **defective exterior GFCI outlet** on the left side of the house and install a **GFCI outlet in the laundry area**.

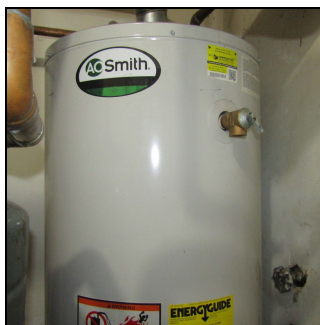
TPR missing extension

- ☐ Water heater delivered hot water to all faucets on the day of inspection.
- ☐ There were no apparent leaks or defects in the water heater.
- ☐ The TPR valve was missing an extension. This could be a safety concern if the valve should fail.
- ❑ **A licensed plumber should install an extension pipe to the water heater TPR valve.**

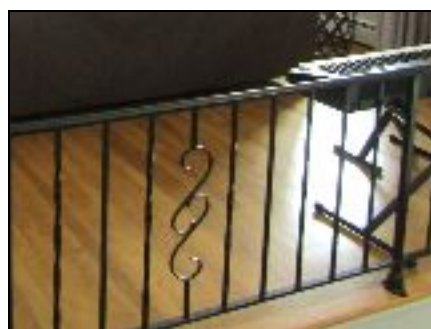
Balusters too wide apart

- ☐ Floors, ceilings, walls, doors and windows were in serviceable condition.
- ☐ Stairwells were in acceptable condition, **except** for the **spacing on the balusters on the railings**, which were **too wide apart**. This is a safety hazard for small children.
- ✓ A qualified person should repair or replace the **entry level railing so that the balusters are spaced no more that 4" apart**.

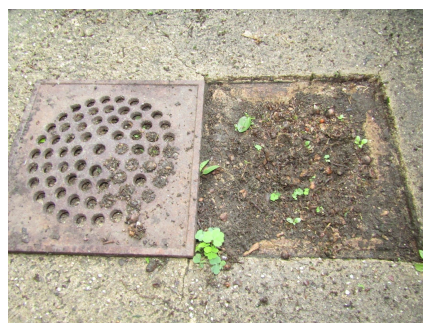
Clogged drain

- ☐ Floors, walls, ceilings, doors and windows were in serviceable condition.
- ☐ The basement had a **dehumidifier** running. Basement humidity levels **below 50%** can **prevent mold and mildew growth** and improve basement air quality.
- ☐ The **storm drain outside the lower level exterior door was clogged**. This could allow rain water to puddle and enter the house.
- ✓ A qualified person should **clean the storm drain in the stairwell outside the lower level exterior door**.

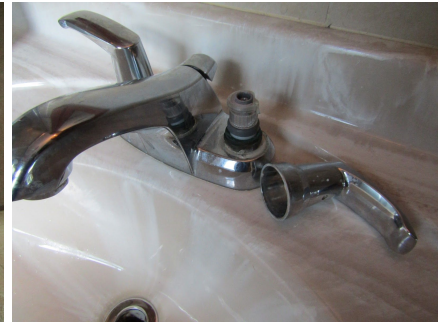
Loose Sink Handle

- ☐ There were no defects or leaks in the toilet or shower; water pressure was acceptable.
- ☐ The cold water **sink faucet handle** was loose or broken.
- ✓ A qualified person should repair or replace the **loose sink faucet handle in the Master bathroom.**

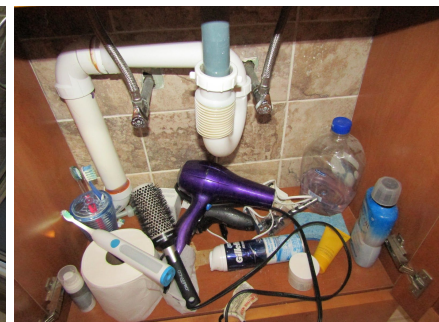
Leaky drain pipe

- ☐ There were no defects or leaks in the **toilet or shower**; **water pressure** was acceptable.
- ☐ The **drain pipe** in the vanity cabinet below the sink **leaked**; a defect.
- ✓ A licensed plumber should repair or replace the **leak in the drain pipe in the lower level bathroom sink.**

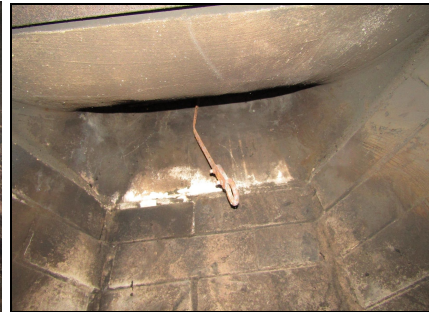
Damper & Flue

- ☐ The damper worked as designed. Creosote buildup was minor.
- ✓ A qualified chimney contractor should conduct a **Level II inspection** and **clean the 1st floor fireplace flue** prior to use.

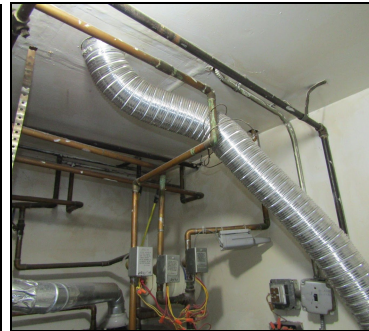
Dryer Vent hose

- ☐ **Evaluation of washers and dryers** is outside the scope of this inspection. As a courtesy they were turned on and appeared to work as designed.
- ☐ As mentioned in the electrical section, the **outlet in the laundry room** was **non-GFCI**.
- ☐ The **flexible dryer vent** hose had several bends, which could result in lint being trapped. This can affect dryer operation and is a potential fire hazard.
- ✓ A licensed electrician should replace the **laundry outlet** with a **GFCI outlet**.
- ✓ Recommend installing a properly sized **rigid dryer vent pipe**; also advise clearing the **dryer vent pipe** frequently.
