Secure Home Inspections of NY, LLC

Client: J. Smith
123 Main St.
Anytown, NY 10000
(914) 555-5555
info@ny-secure.com

Inspection Date: 3/1/18
Inspector: John Mondello
NY State ID: 16000055914
Report No. 040218-B
jpmondello@outlook.com

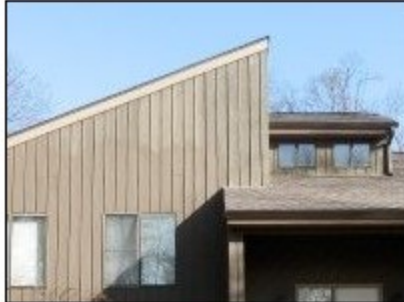
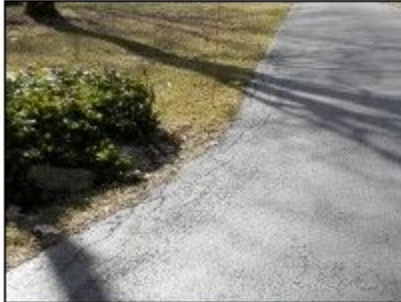
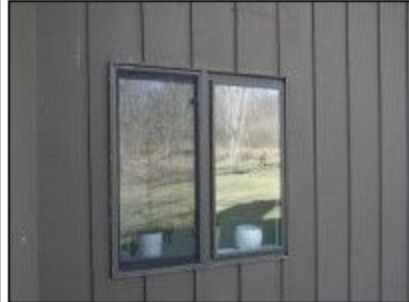
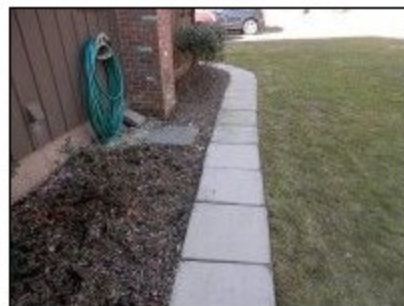
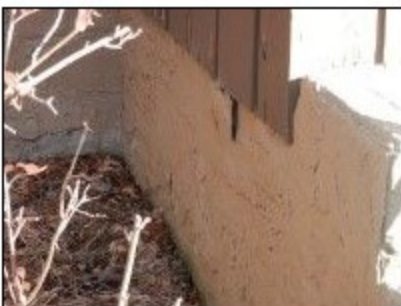
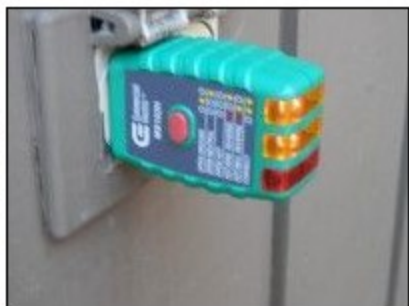
- 1)

The exterior grounds, foundation walls, grading, walkways and windows were in acceptable condition. Outside GFCI outlets tested and operated as designed.. Did note some paint peeling in small areas of the exterior wood siding and trim . This could result in the wood rotting if left unattended The driveway was graded away from the home and was in acceptable condition. Noted minor asphalt cracks in some areas which could become a problem over time. Recommend monitoring and routine maintenance.

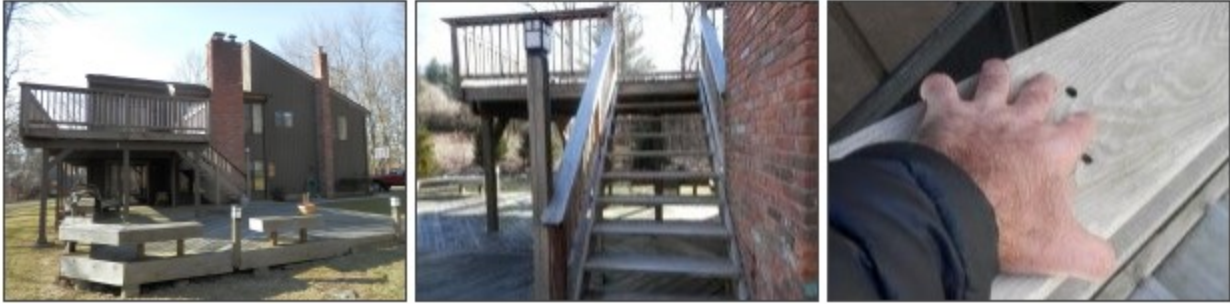
- 2)

**The upper deck footings, railings, and handrails showed signs of wear.** The steps had open risers. This could be a safety hazard for children. Unable to observe the concealed area below the lower deck to examine the footings, ledger boards or joists. The proximity of deck benches to the edges of the lower deck may present a safety issue. Consider installing railings to prevent accidental falls. Recommend a qualified contractor evaluate and repair or replace deck components as necessary.
-

**The upper deck footings, railings, and handrails showed signs of wear.** The steps had open risers. This could be a safety hazard for children. Unable to observe the concealed area below the lower deck to examine the footings, ledger boards or joists. The proximity of deck benches to the edges of the lower deck may present a safety issue. Consider installing railings to prevent accidental falls. Recommend a qualified contractor evaluate and repair or replace deck components as necessary. (P. 4)

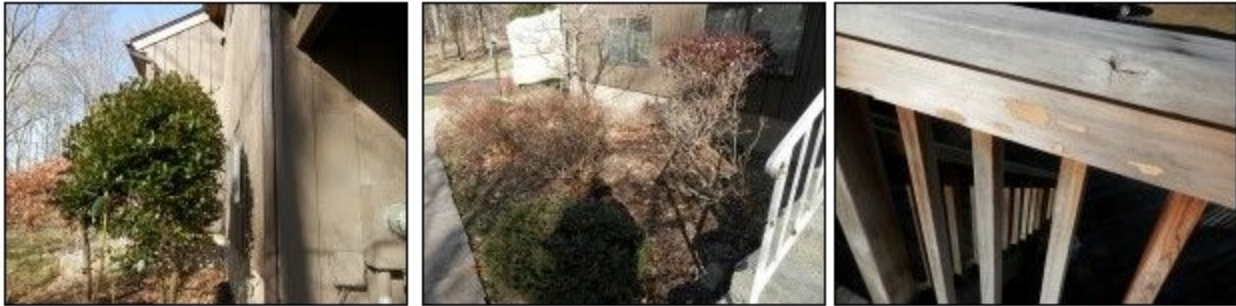
- 3)

**Shrubs were in contact with wood siding.** While there is no evidence of moisture intrusion, over time foliage can stain and/or degrade the siding. Recommend pruning or moving the shrubs. The wood siding and deck showed evidence of repairs from minor insect damage. Recommend evaluation by a qualified pest control company.
-

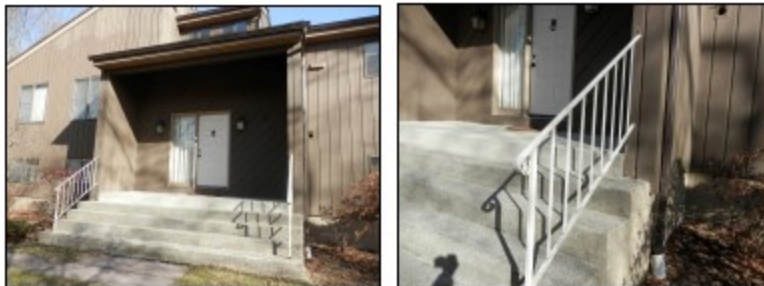
- 4)

**The front entry stoop and landing** were in acceptable condition. However, a railing was loose, which is a hazard. It should be repaired or replaced by a qualified contractor.
-

**The front entry stoop and landing** were in acceptable condition. However, a railing was loose, which is a hazard. It should be repaired or replaced by a qualified contractor. (P. 4)

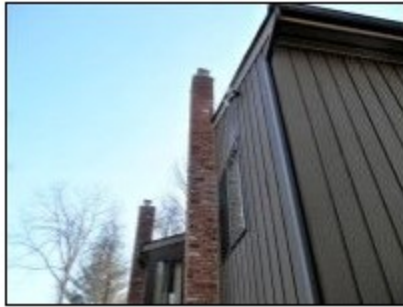
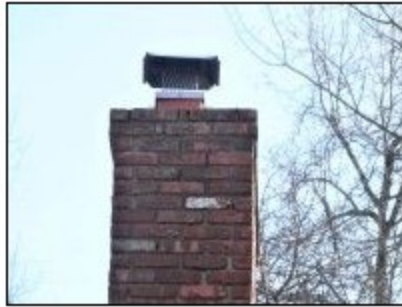
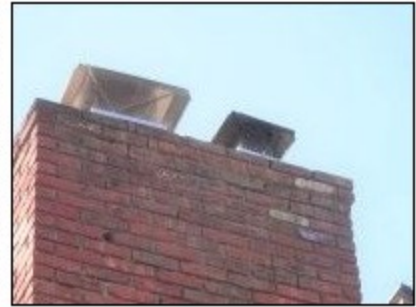
- 5)

Both chimneys were observed from the ground. Unable to evaluate the condition of the flue, chimney caps or spark arrestors. Recommend a qualified chimney technician perform a [Level II inspection](#), and evaluate the condition of the chimney flashing, bricks and mortar and repair or replace as necessary prior to closing.
-

**Both chimneys were observed from the ground.** Unable to evaluate the condition of the flue, chimney caps or spark arrestors. Recommend a qualified chimney technician perform a [Level II inspection](#), and evaluate the condition of the chimney flashing, bricks and mortar and repair or replace as necessary prior to closing. (P.5)

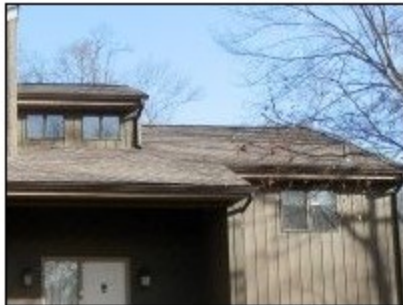
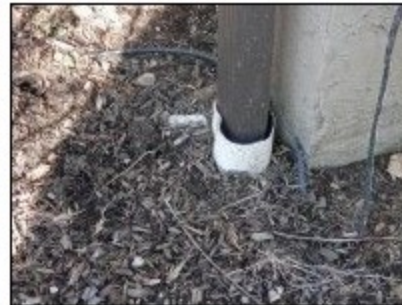
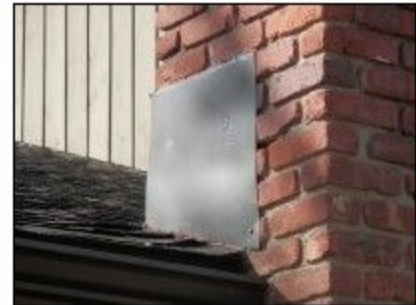
- 6)

From what could be observed from the ground, roof shingles, gutters and downspouts connected to drain pipes appeared to be in serviceable condition. Recommend routine cleaning of gutters and downspouts. This will help keep water away from the foundation.
-

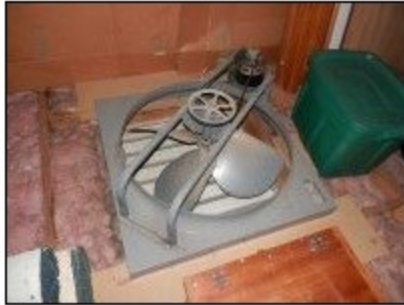
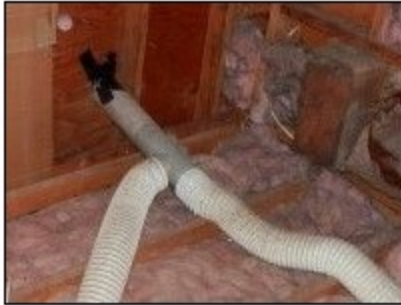
- 7) ✘ The whole house attic fan operated satisfactorily. Did note two attic exhaust fan hoses joined at a "T" connection leading to a single exterior vent. This could allow one of the bathroom's exhaust to return to the other bathroom instead of exiting thru the attic vent. Also, the hose is attached to the sidewall vent with duct tape and is not sufficiently secured. Recommend a qualified contractor evaluate and repair or replace as needed.

**The whole house attic fan** operated satisfactorily. Did note **two attic exhaust fan hoses joined at a "T"** connection leading to a single exterior vent. This could allow one of the bathroom's exhaust to return to the other bathroom instead of exiting thru the attic vent. Also, the hose is attached to the sidewall vent with duct tape and is not sufficiently secured. Recommend a qualified contractor evaluate and repair or replace as needed.. (P. 6)

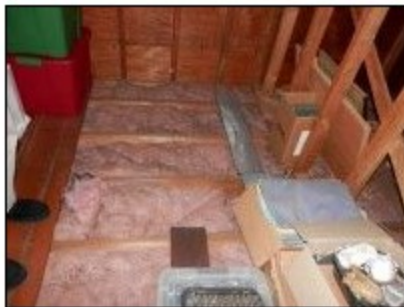
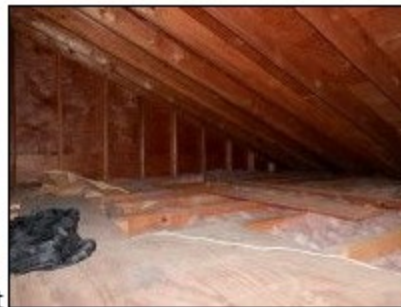
- 8) 🔍 🚧 **Stored materials** prevented a complete inspection of the attic. I recommend a follow-up inspection once attic obstructions are removed. Unable to determine if roof soffits were obstructed. Inadequate attic ventilation may result in high attic and roof surface temperatures, reduce the life of the roof covering and insulation materials and increase cooling costs. A qualified contractor should evaluate and repair or replace as necessary.

**Stored materials** prevented a complete inspection of the attic. I recommend a follow-up inspection once attic obstructions are removed. Unable to determine if roof soffits were obstructed. Inadequate attic ventilation may result in high attic and roof surface temperatures, reduce the life of the roof covering and insulation materials and increase cooling costs. A qualified contractor should evaluate and repair or replace as necessary. (Page 6)

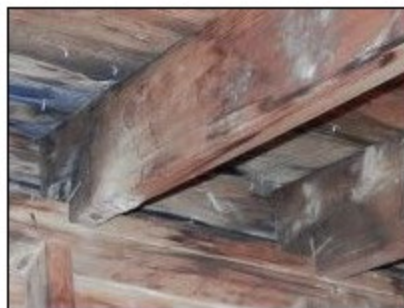
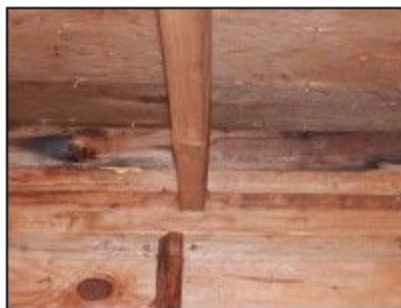
- 9) 🔍 🏠 **Stained sheathing and rafters** with low moisture readings are an indication of past water intrusion. Despite recent heavy rains and snowfall, these areas were dry on the day of the inspection. These leaks may pre-date the existing roof surface. Recommend cleaning and monitoring these areas in the future to determine if active leaks exist.

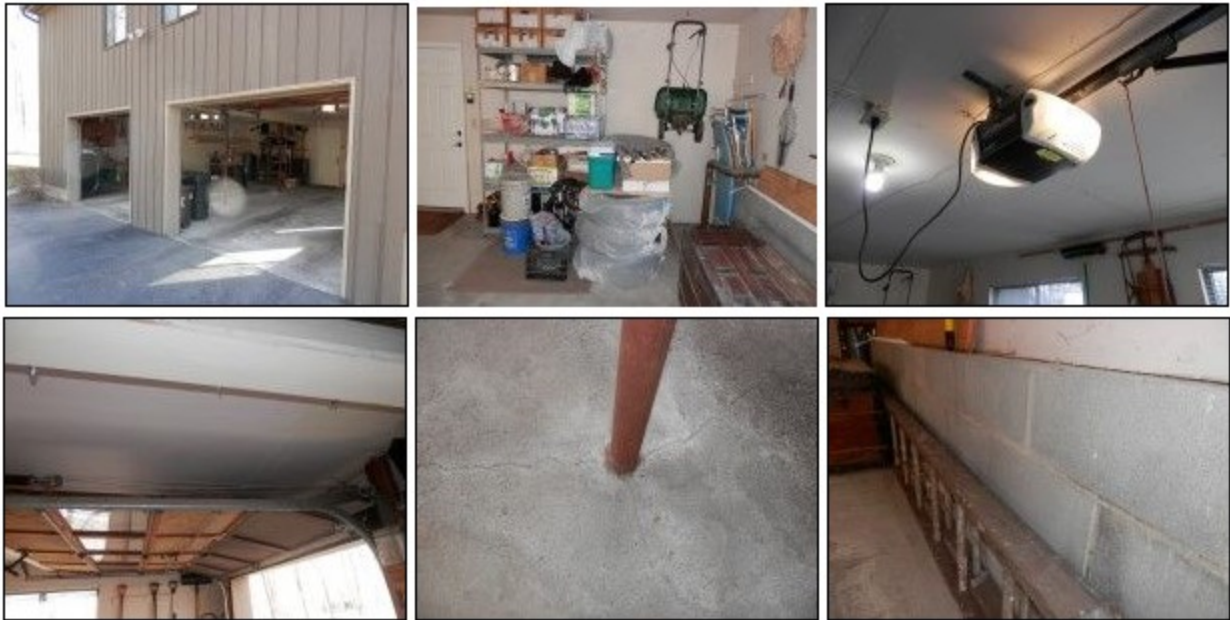
- 11)

. Garage doors, safety cables and the auto-reverse function performed as expected. The garage ceiling, walls and windows were also in serviceable condition. The concrete floor showed minor pitting from salt and other ice melting chemicals over the years. A garage door torsion spring is sagging and worn; this is a safety hazard. Recommend a qualified technician evaluate and repair or replace.

**. Garage doors,, safety cables and the auto-reverse function** performed as expected. The garage ceiling, walls and windows were also in serviceable condition. The concrete floor showed minor pitting from salt and other ice melting chemicals over the years. A garage door torsion spring is sagging and worn; this is a safety hazard. Recommend a qualified technician evaluate and repair or replace. (P 7.)

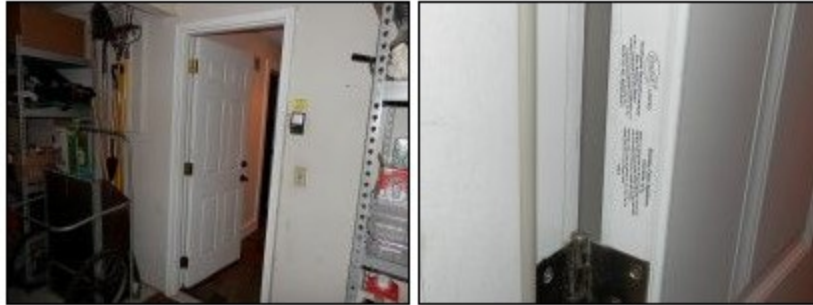
12) ✂ The inspector does not determine the adequacy of **firewall** (drywall) ratings as it pertains to attached garage structures, as the requirements for garages vary between municipalities.

⊕ Did note that the garage-house door is fire-rated (20 mins) but the door does not have an **auto-closing device or hinge**. This is a safety concern; an open garage door could allow vehicles fumes or smoke from a garage fire to enter the home. Recommend a qualified carpenter install or repair as needed.

Did note that the garage-house door is fire-rated (20 mins) but the door does not have an **auto-closing device or hinge**. This is a safety concern; an open garage door could allow vehicles fumes or smoke from a garage fire to enter the home. Recommend a qualified carpenter install or repair as needed. (P. 8)

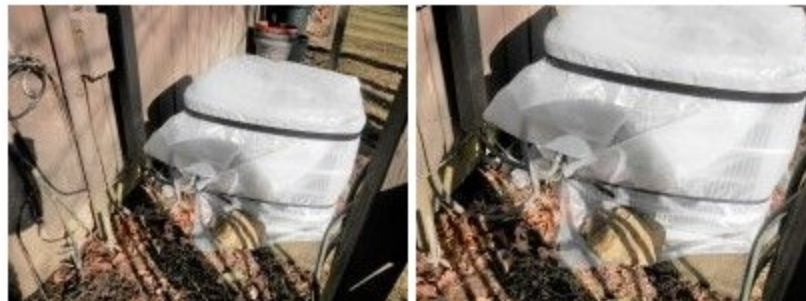
13) 🔍👉 The A/C system was not turned on due to cold weather. Did note the compressor was covered in plastic, which can trap moisture and damage the unit. Recommend removing the cover. The system should be thoroughly evaluated by a qualified technician prior to closing. (Please also see Attic 2 section)

**The A/C system** was not turned on due to cold weather. Did note the compressor was covered in plastic, which can trap moisture and damage the unit. Recommend removing the cover. The system should be thoroughly evaluated by a qualified technician prior to closing. (P. 8)

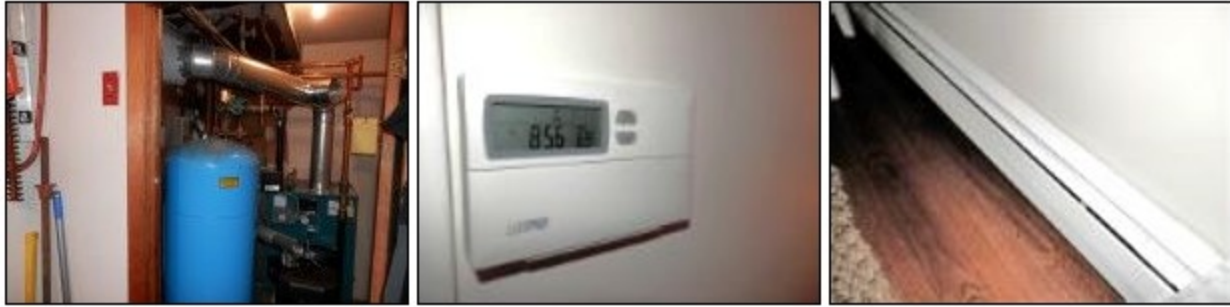
- 14)

On the day of inspection, the **boiler, thermostat and baseboard heating system** produced heat and operated as designed. Recommend continuing the regular maintenance schedule currently in place.
-

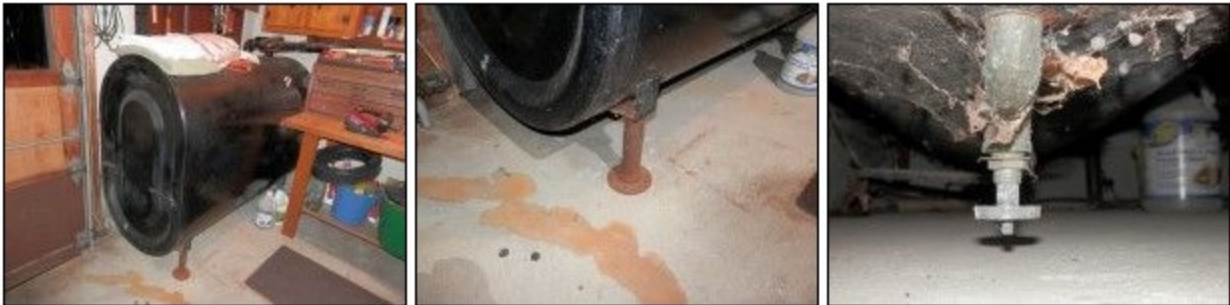
- 15)

**Stored items obstructed the view of the oil storage tank.** However, did observe that the fuel oil components worked properly, and no leaks were detected on the day of inspection. Expected effective life of an oil storage tank is 20-25 years. This tank appears to be midlife or older.

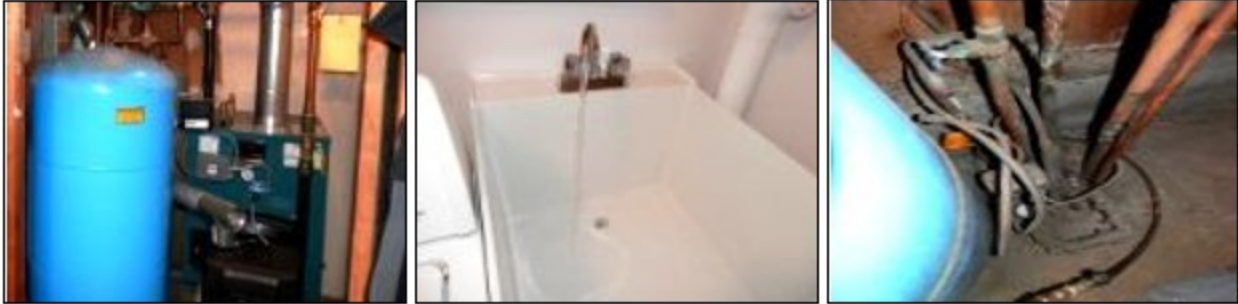
- 16)

On the day of inspection, the well pump cycled at an acceptable rate and water was delivered to all household faucets under adequate pressure. There were no leaks detected in any of the plumbing systems. There was an acceptable decrease in pressure with multiple fixtures running.
-

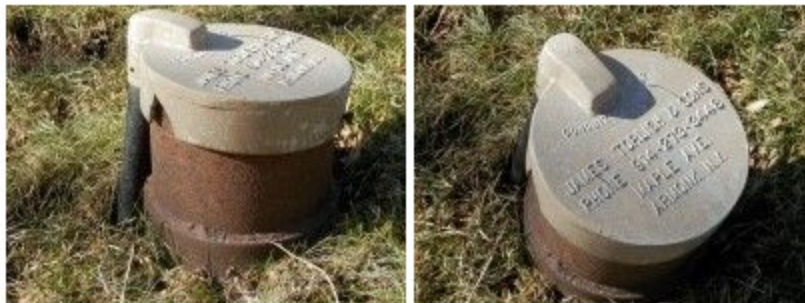
- 17)

**The drilled well sanitary cap is too low to the ground and improperly sealed.** This is a health and safety issue because the cap is supposed to prevent contaminants from getting into the water supply. Recommend having a qualified contractor evaluate the well system components prior to closing. Also suggest asking the owner for any well maintenance records.

**The drilled well sanitary cap** is too low to the ground and improperly sealed. This is a health and safety issue because the cap is supposed to prevent contaminants from getting into the water supply. Recommend having a qualified contractor evaluate the well system components prior to closing. Also suggest asking the owner for any well maintenance records. (P. 10)

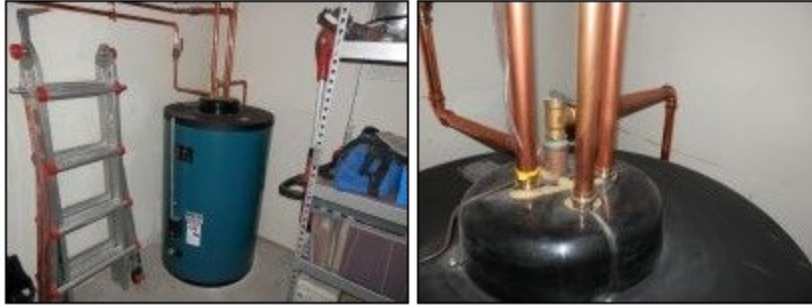
- 19) The hot water heater is part of the boiler system and operated as designed on the day of the inspection. It has a properly installed temperature relief valve and extension. For more in how indirect water systems work: [CLICK HERE](#).

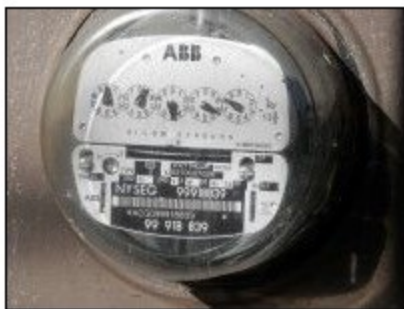
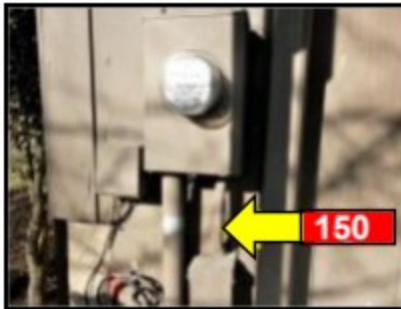
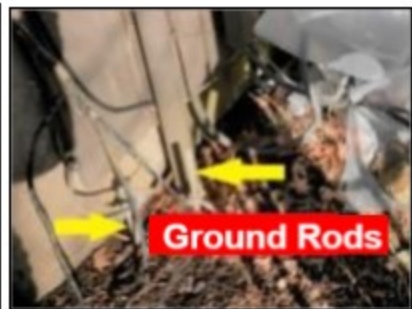
- 20) Noted the underground service entrance conductor was rated for 150 amps and appeared to be securely fastened to the side of the home. Also noted 2 ground rods securely fastened.

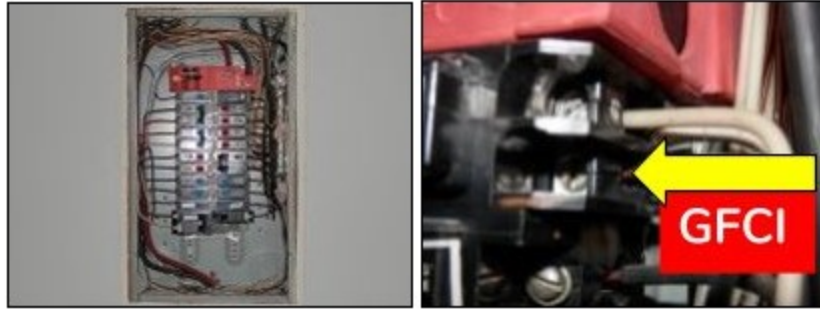
21) There were no visible defects in the main panel at time of inspection. Recommend new home owners become familiar with the main panel GFCI breaker, connected to several bathroom and kitchen outlets at once.. If not GFCI-protected, receptacles in wet areas pose a shock hazard. In this home, if a GFCI breaker is tripped, it must be reset at the panel in the downstairs basement. For more information, visit [HERE](#)

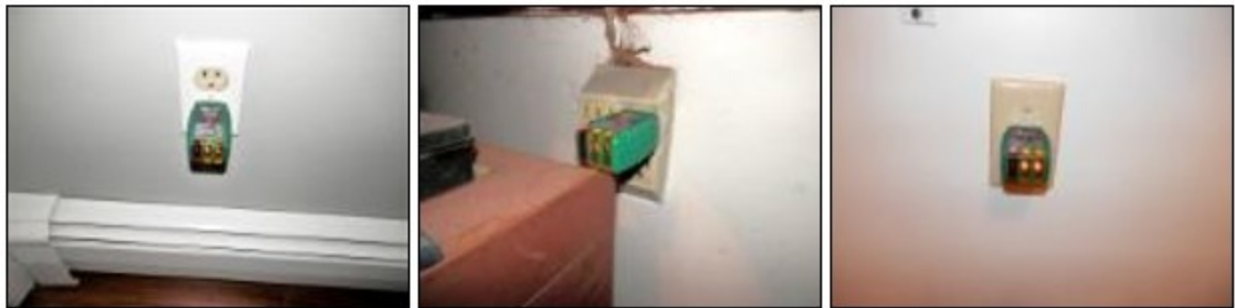
22) . A representative sampling of outlets and light fixtures were tested. Most outlets were 3-pronged. Furniture and/or storage restricted access to some electrical components which may not be inspected. Electrical components concealed behind finished surfaces are not inspected. The inspection does not include remote control devices, alarm systems and components, doorbells or any other low voltage wiring systems.

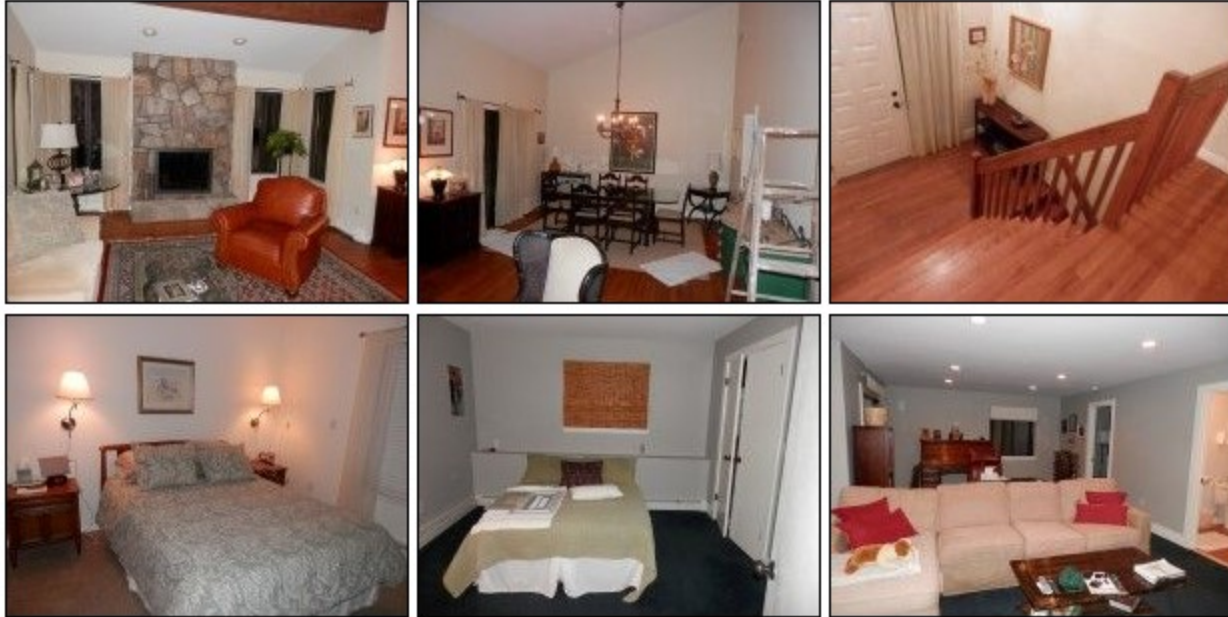
23) On the day of inspection, **numerous wall, floor and other surfaces were obscured** by furniture or stored items, preventing a full evaluation of some areas of the home. No defects were noted in what could be observed in the general interior. Walls, ceilings, doors, floors, stairs and a representative sampling of windows, wall outlets and switches were in acceptable condition.

24) **No carbon monoxide detectors** were located in the home. The smoke alarms were not tested as this is outside the NY Standards of Practice for Home Inspectors. It is a good practice for new owners to replace all smoke alarms, CO detectors and fire extinguishers, with careful attention to proper placement by a licensed electrician.

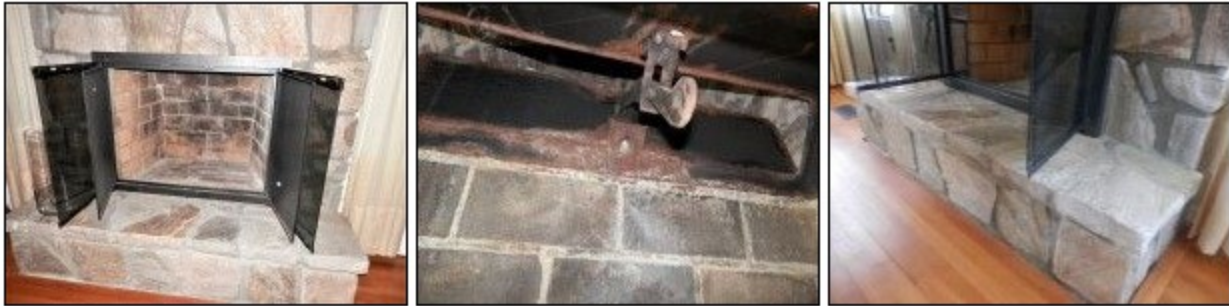
- 26)

A Level 1 inspection was performed. The fire box condition was acceptable and the damper performed as designed. Did note an area of concern: there were gaps between fireplace metal frame and the stone surround. Given the proximity of the wood floor and adjacent curtains, this could create a fire hazard. Recommend a Level II inspection of all fireplace components by a qualified chimney sweep technician prior to closing.
-

**A Level 1 fireplace/chimney inspection was performed.** The fire box condition was acceptable and the damper performed as designed. Did note an area of concern: there were gaps between fireplace metal frame and the stone surround. Given the proximity of the wood floor and adjacent curtains, this could create a fire hazard. **Recommend a Level II inspection** of all fireplace components by a qualified chimney sweep technician prior to closing. (P. 12)

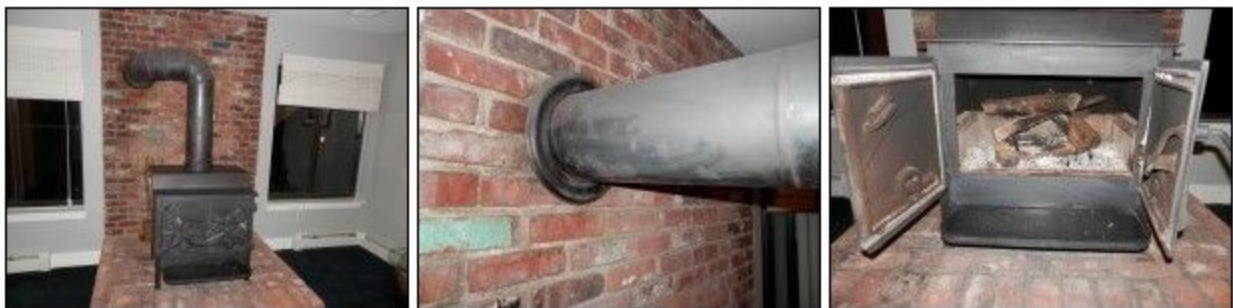
- 27)

The wood stove was not operating on the day of inspection. Recommend a Level II inspection of the wood stove components by a qualified chimney service contractor prior to closing.
-

**The wood stove was not operating** on the day of inspection. **Recommend a Level II inspection** of the wood stove components by a qualified chimney service contractor prior to closing. (P. 12)

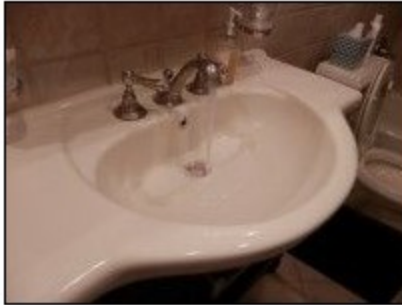
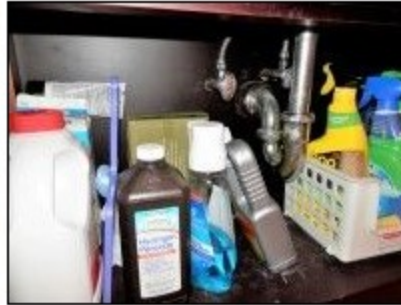
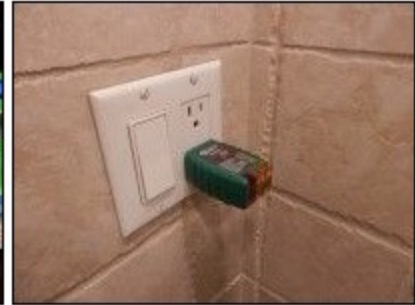
28)

**No noted defects in bathroom.** The GFI outlet performed when tested (please also see the Electric Section). There was an acceptable drop in pressure when the functional flow test was performed.

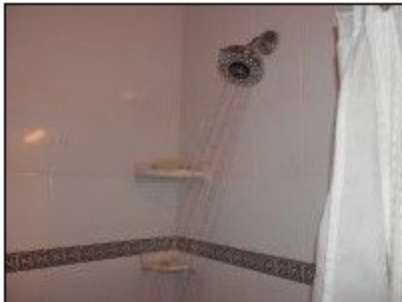
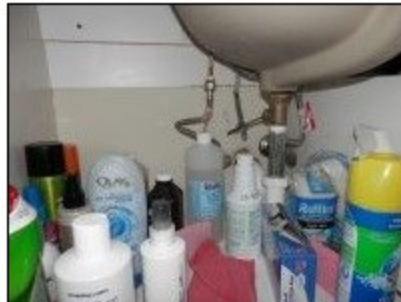
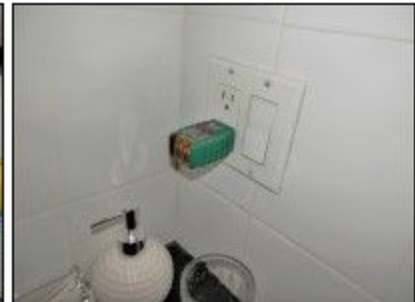
29)

**No noted defects in bathroom.** The GFI outlet performed when tested (please also see the Electric Section). There was an acceptable drop in pressure when the functional flow test was performed.

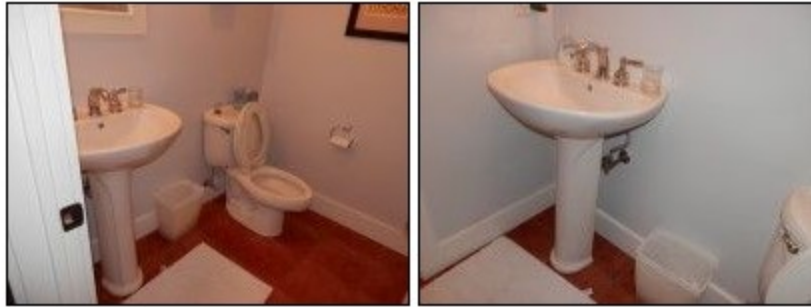
30)

**No noted defects in bathroom.** The GFCI outlet performed when tested (please also see the Electric Section). There was an acceptable drop in pressure when the functional flow test was performed.

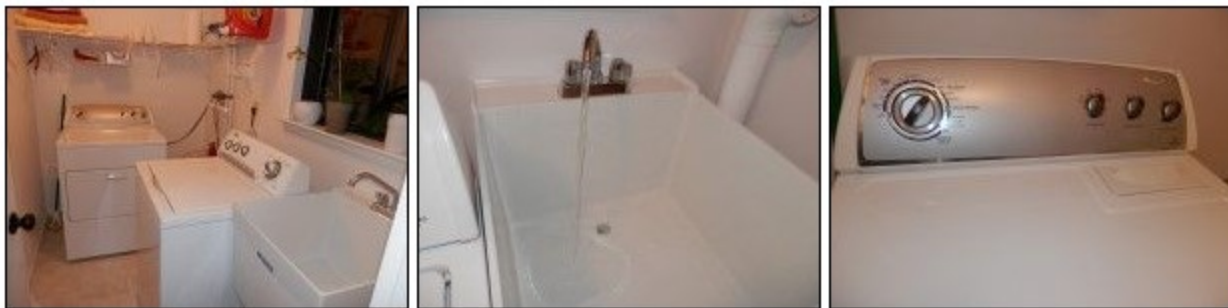
31)

**There were no leaks observed** from the laundry room sink or plumbing on the day of inspection. Evaluation of appliances is outside the Standards of Practice for Home Inspectors. As a courtesy we noted that the appliances did power up. Recommend having your realtor ask if there are any appliance warranties that are transferable.

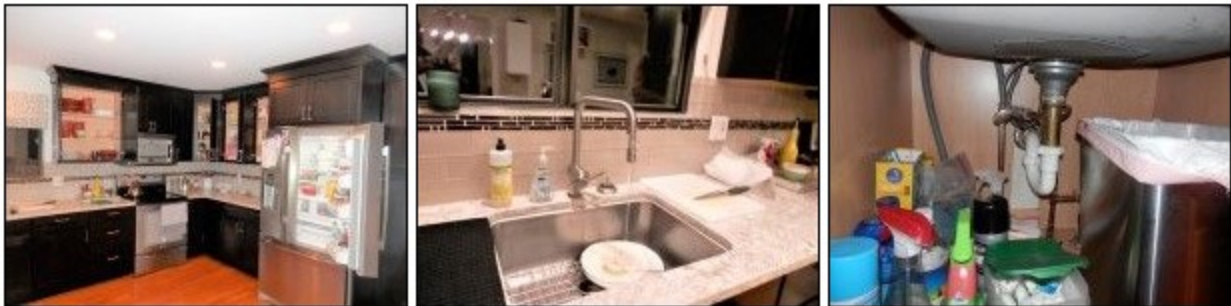
32)

**There were no apparent defects in the kitchen.** The cabinets and counters were securely attached, GFCI outlets operated as designed, there were no leaks and the doors, windows, walls and ceiling were all in acceptable condition.
