Secure Home Inspections of NY, LLC

Home Inspection Report

Client: Stratford, CT 06615

Inspection Date: 2019

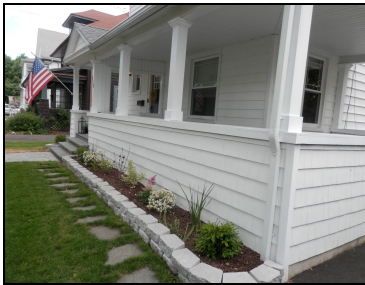
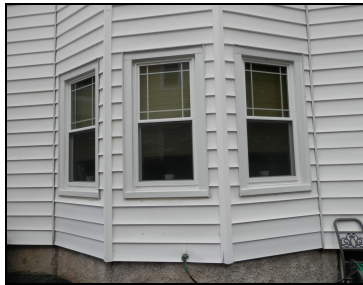
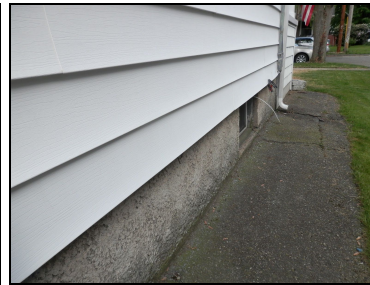
- ☐ The exterior walls were covered in **vinyl shingles**; most **windows** had screens.
- ☐ **The exterior windows, doors and siding** were in acceptable condition.
- ☐ **Porch surround and support columns** were in serviceable condition.

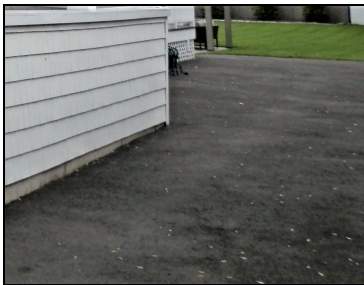
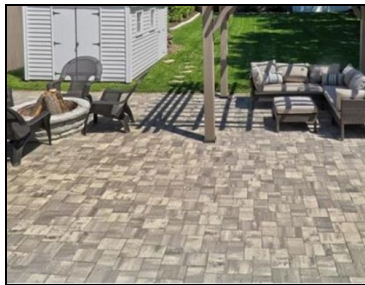
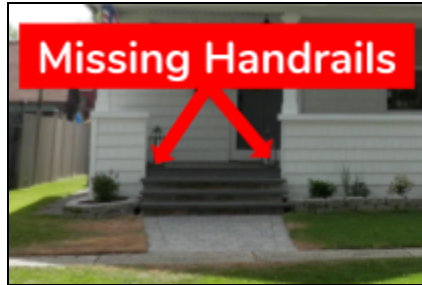
- ☐ The front **walkway, porch steps, asphalt driveway** and **rear patio** were in serviceable condition.
- ☐ The **front porch steps** were **missing railings**. This is a safety hazard, especially in icy weather.
- ✓ **Recommend a qualified contractor install railings on the front porch steps** as needed.

- P. 4 Recommend a qualified contractor **install railings on the front porch steps** as needed.
- P. 5 Recommend adding **extensions to gutter downspouts** and clearing **downspout drains** as needed..

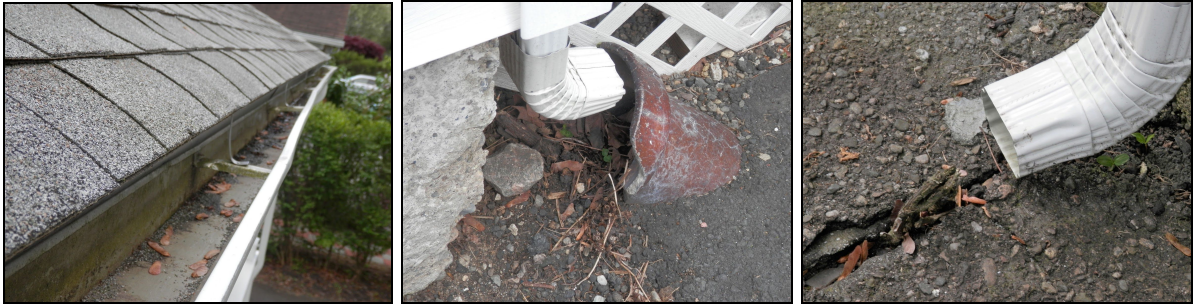
- ❑ **Aluminum gutters and downspouts** make up the roof drainage system.
- ❑ Some lacked **extensions** long enough to divert water away from the foundation.
- ❑ Did observe one **gutter drain** in the rear that appeared to be obstructed by debris.
- ❑ **Directing water away from the foundation is critical to maintaining a dry basement.**
- ✓ **Recommend adding extensions to gutter downspouts and clearing downspout drains as needed** (please also see **Basement Section, p.8**).

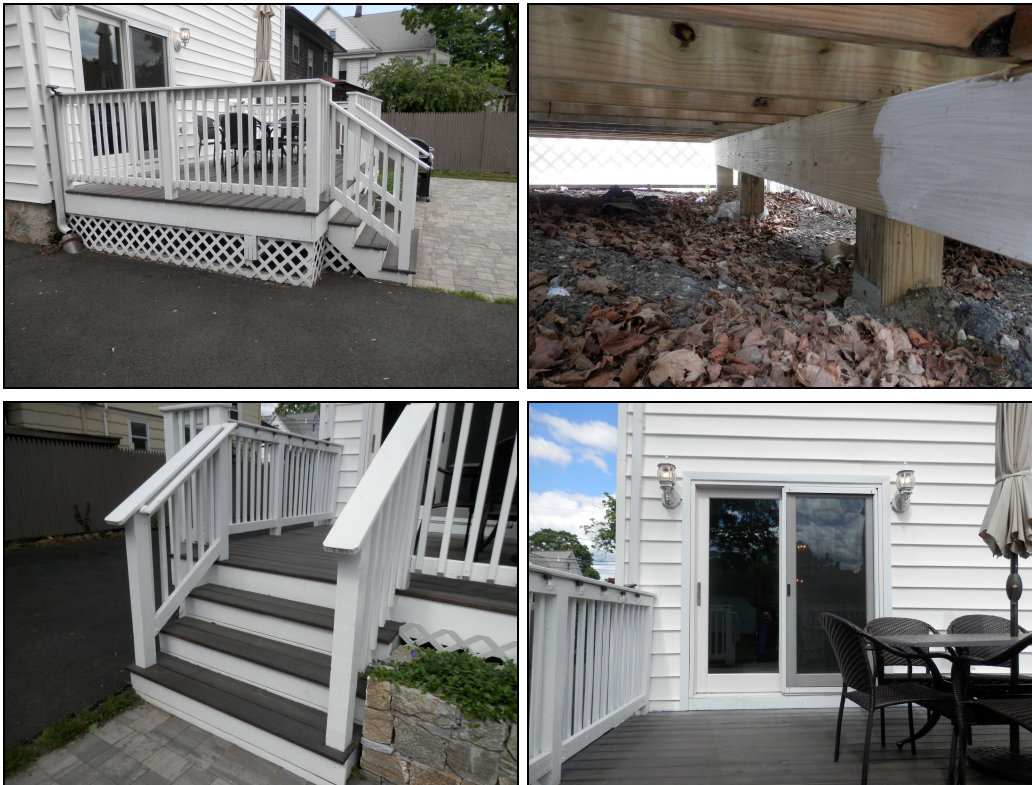
- ❑ **The rear deck** appeared to be structurally sound. Footings, decking, ledger board, handrails and railings were all in serviceable condition.

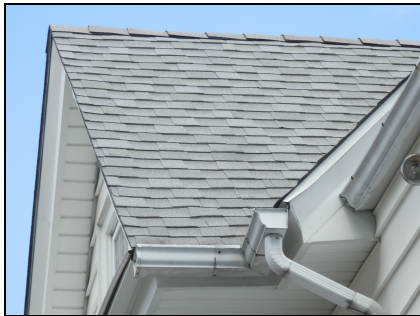
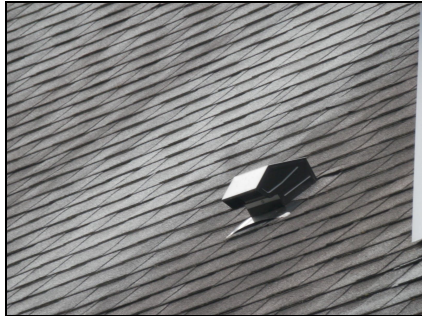
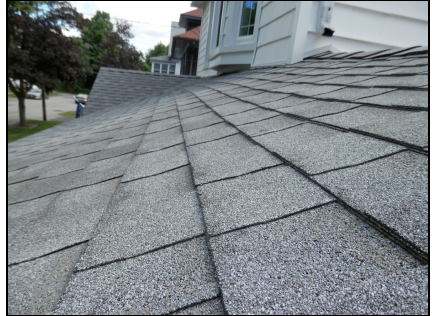
- ❑ From what could be observed, the age of the asphalt **roof shingles** appeared to be midlife. This type of shingle typically lasts 20-25 years.
- ❑ Did not observe any roof ventilation systems or chimney.

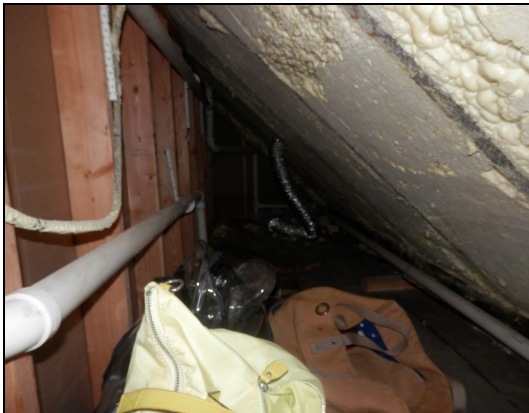
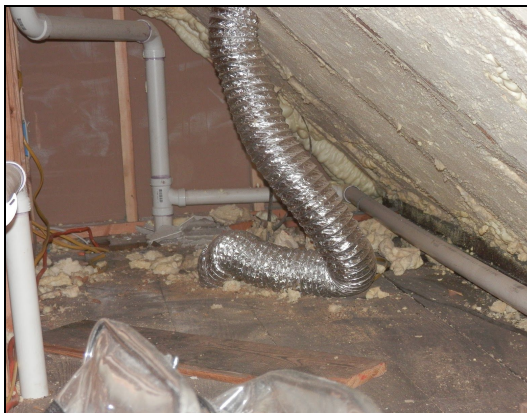
- ❑ The finished attic provided limited access to rafters and roof decking thru doors in a knee wall inside a bedroom closet.
- ❑ From what could be observed, **the roof decking, rafters and solid foam insulation** were in **acceptable condition**.
- ❑ Did not detect any evidence of **moisture penetration**.

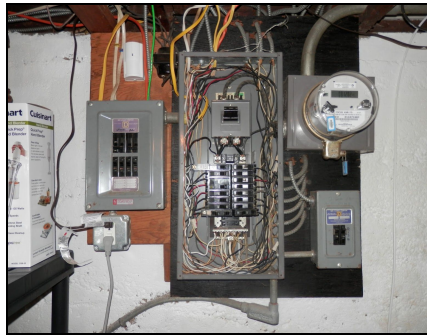
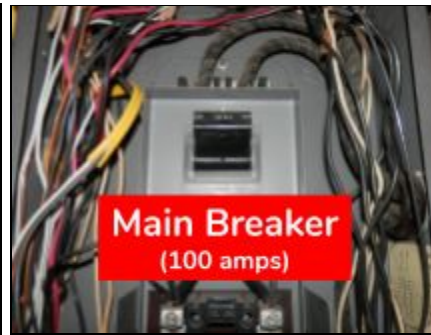
- ❑ The main panel was rated at 100 amps, there are two adjacent panels: one labeled "Dryer - AC" and another labeled "Dish".
- ❑ All three panels were in acceptable condition.

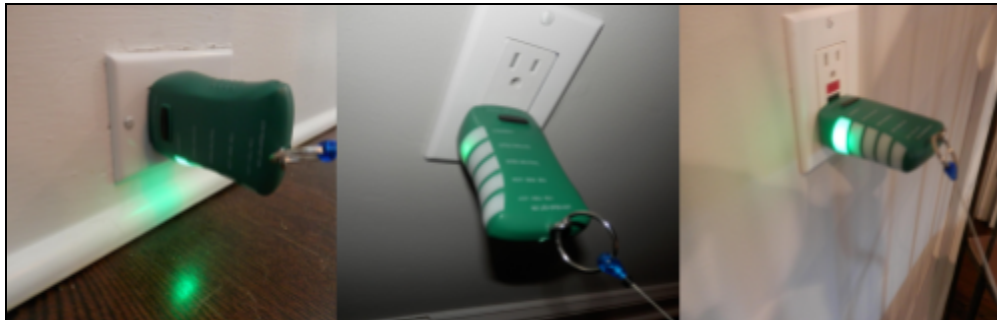
- ❑ A representative sampling of regular and GFCI outlets and light fixtures were tested. Most were in working order.

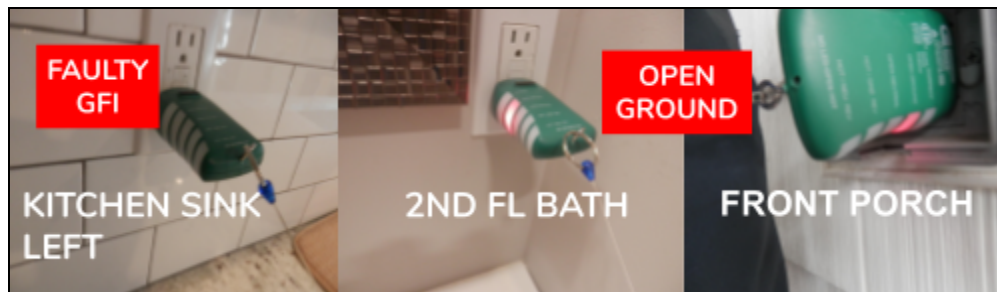
- ❑ Did observe a **faulty GFI outlet in the kitchen** to the left of the sink, and **open ground outlets in the 2nd floor bathroom and front porch**.
- ✓ Recommend a licensed electrician repair or replace the **faulty outlets**.

- P. 7 Recommend a licensed electrician repair or replace the **faulty outlets in the kitchen, 2nd floor bathroom and front porch.**
- P. 8 Recommend having a qualified contractor **seal cracks** along exterior foundation walls and on walkways on the sides and rear of the house.

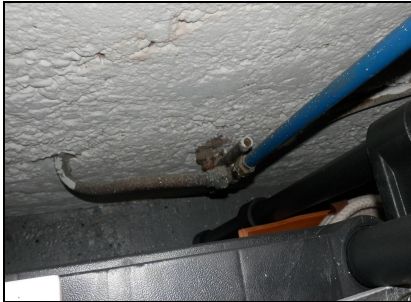
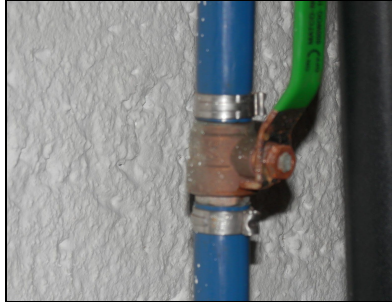
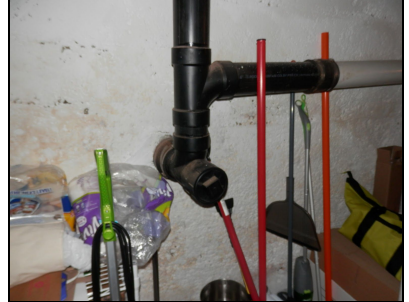
- ☐ The visible **water supply lines** throughout the dwelling were pvc pipe.
- ☐ **Ran water** in the kitchens and bathrooms for extended periods of time, no leaks were detected. **Water flow** throughout the home was **average**.

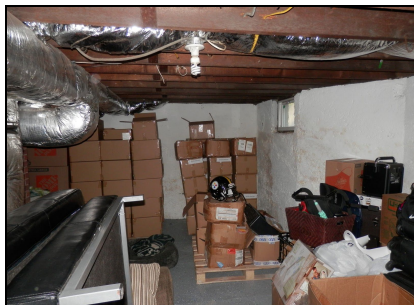
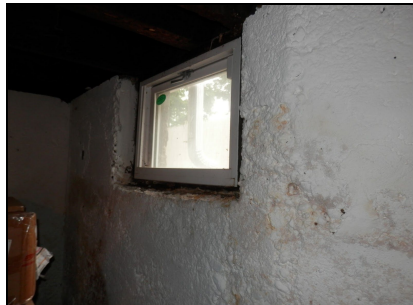
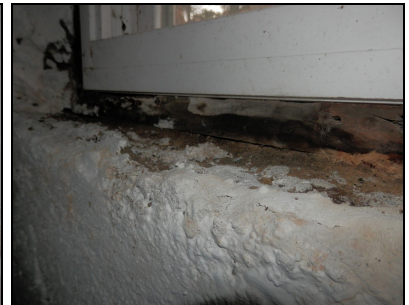
- ☐ **Stored items** prevented a complete inspection of the basement, which contained electrical, plumbing and HVAC equipment.
- ☐ **The basement ceiling, support columns and joists** were in acceptable condition.
- ☐ The **basement floor was dry** at the time of the inspection.
- ☐ Did note the presence of a **dehumidifier**. Did not detect any visible moisture on the basement walls; However, did note **stains on basement walls** and one rear **window frame**, indicating past moisture intrusion, **due in part to poor gutter drainage (p.5)**.
- ✓ **Recommend having a qualified contractor seal cracks along exterior foundation walls, and on walkways on the sides of the house.**

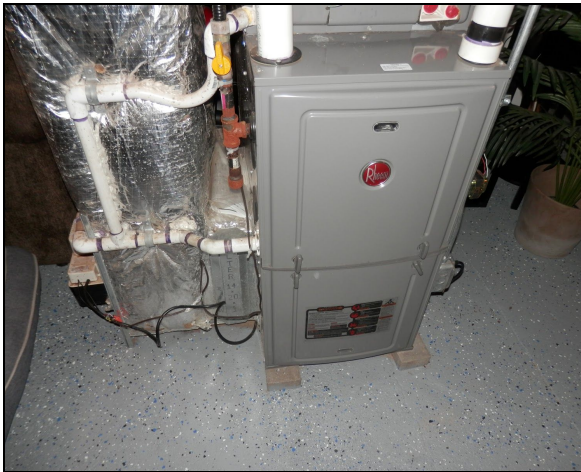
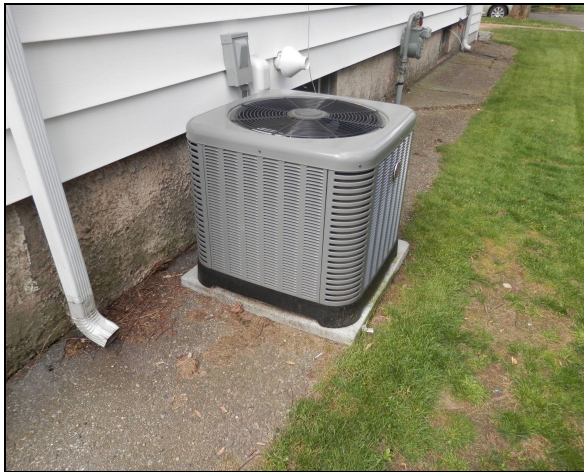
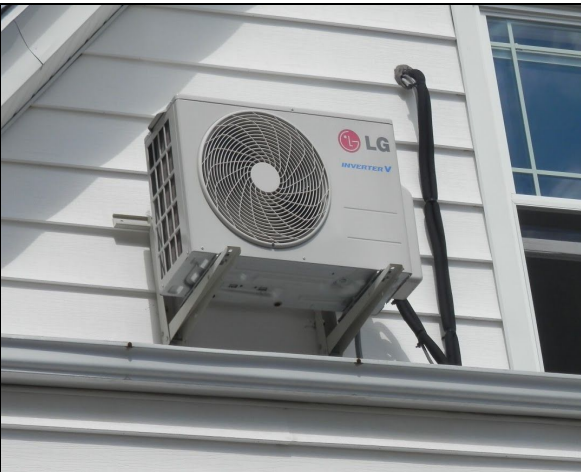
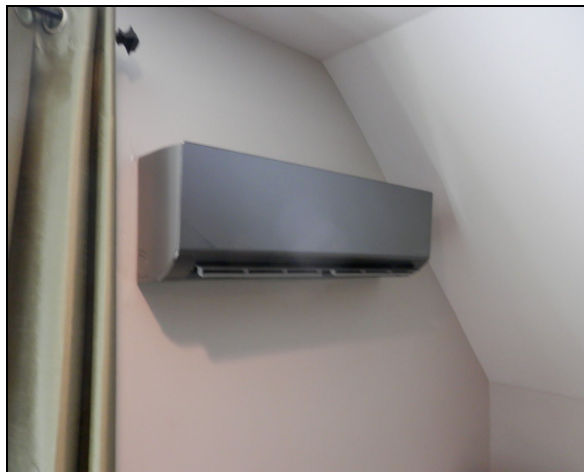
- ☐ The Rheem furnace/air handler supplied warm and cool air to the **1st and 2nd floor zones on separate thermostats** on the day of inspection. The air conditioner condenser unit was on the side of the house on a level concrete pad.
- ☐ **3rd floor heating** and cooling was supplied by an **LG heat pump unit** mounted on the wall. It's condenser unit was mounted on the exterior rear wall.
- ☐ Both units were turned on and **supplied cool air** on the day of inspection
- ☐ The **furnace shut offs** are at the **top of the basement stairs** and **on the furnace unit**.
- ☐ Did **not note** documentation showing any record of **service** to the HVAC systems.
- ✓ Upon taking possession of the house, recommend hiring a qualified furnace contractor to service the furnace, instruct the new owner on the proper operation of the boiler, and set up an annual maintenance program.

- P. 9 Upon taking possession of the house, recommend hiring a qualified furnace contractor to **service the furnace, instruct the new owner on the proper operation of the boiler, and set up an annual maintenance program.**

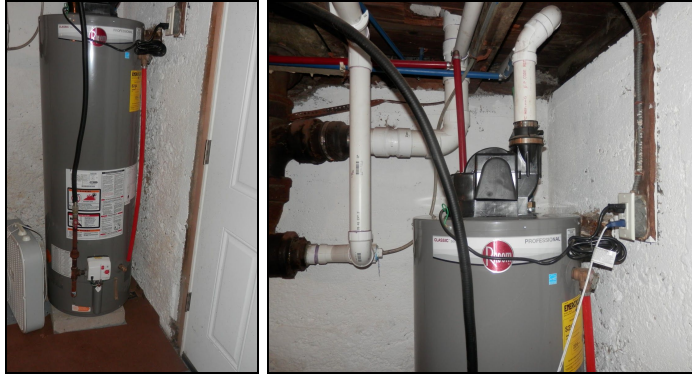
- ❑ The Rheem 40-gallon water heater, manufactured in 2016, supplied hot water to all faucets on the day of inspection.
- ❑ The heater has a 6-year warranty. Download the water heater operating manual [here](#).
- ✓ Suggest asking seller for a copy of the warranties for the water heater and furnace.

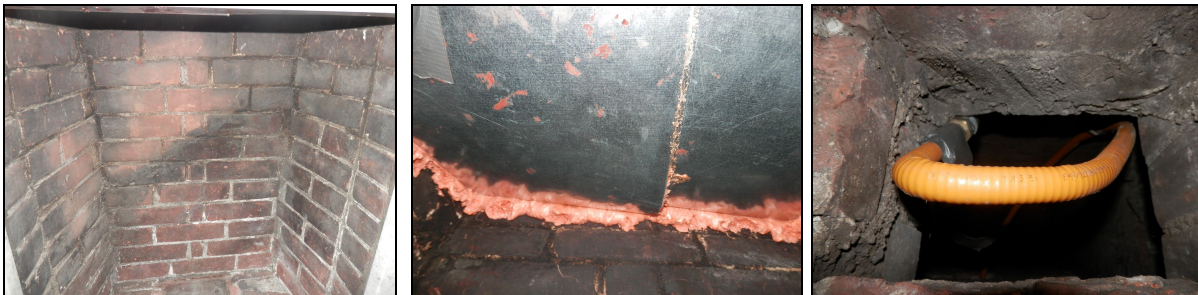
- ❑ The brick fire box condition was acceptable.
- ❑ The damper was sealed shut and the flue and chimney removed, per seller.
- ❑ There was a gas line visible in an opening in the bottom of the fireplace hearth, presumably to provide for installation of a ventless gas fireplace.

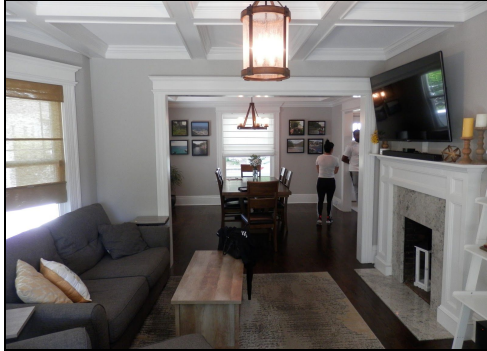
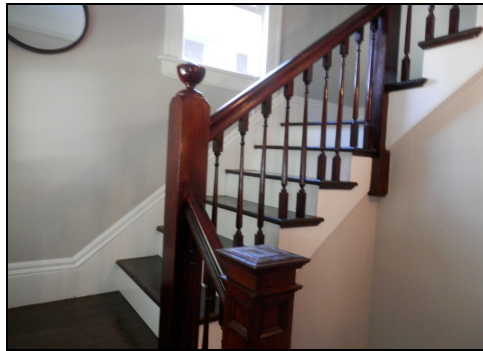
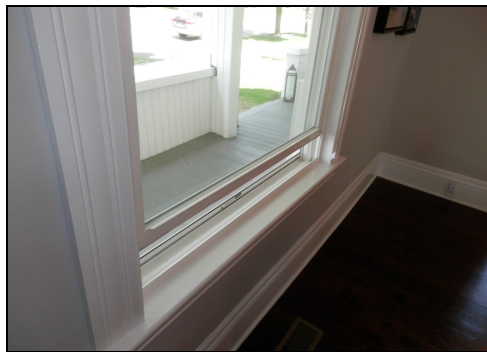
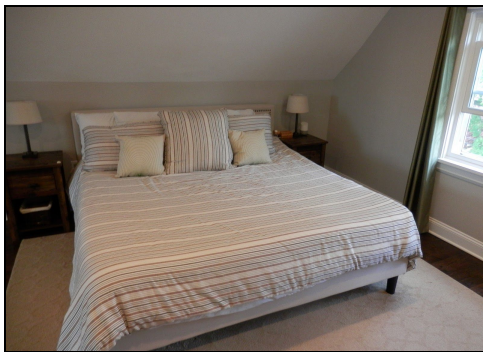
- ☐ **Personal belongings, furniture and stored items** prevented a complete evaluation of the house interior.
- ☐ From what could be observed on the day of inspection, there were no issues with **walls, ceilings, floors or staircases**.
- ☐ **Exterior doors** were operated and found to be functional.
- ☐ A representative sampling of **windows** were tested; all functioned satisfactorily.
- ☐ Smoke detectors and CO detectors were noted throughout the house.
- ✓ The age of **batteries in smoke detectors and carbon monoxide detectors** is not evident; Recommend replacing these safety devices upon occupancy of the home.
- ✓ Recommend **changing all exterior door locks** upon occupancy.

- ☐ Did note evidence of **moisture intrusion in the 2nd floor stairwell ceiling**. Seller advised it was an old leak that was repaired.
- ✓ **Recommend monitoring the area.**

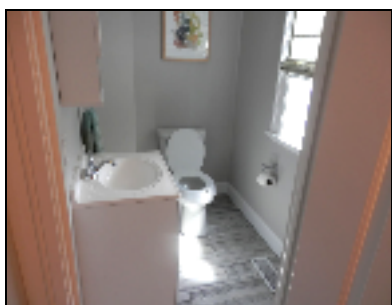
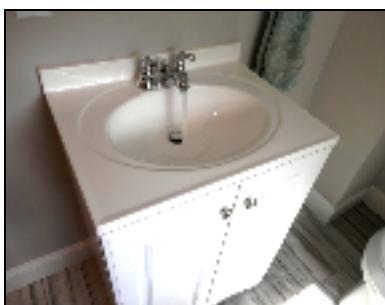
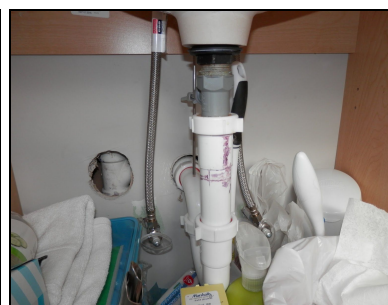
- ☐ The bathroom **walls, ceiling and floor** were in acceptable condition.
- ☐ **No plumbing or electrical defects or leaks** were noted.

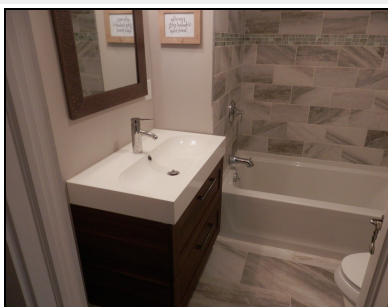
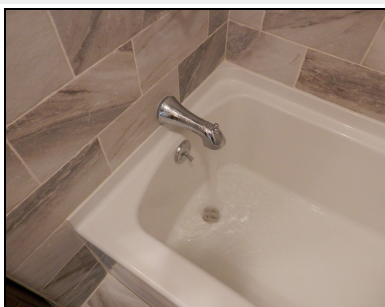
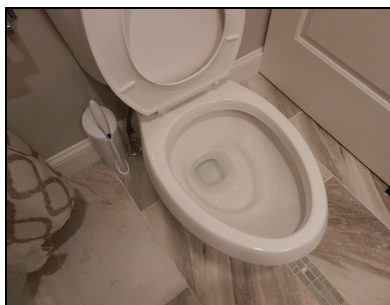
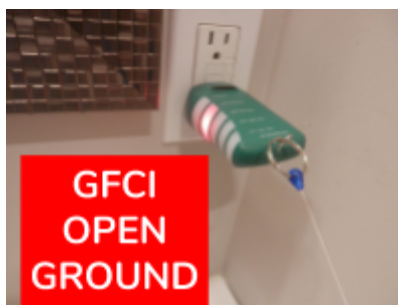
- ☐ The bathroom **walls, ceiling and floor** were in acceptable condition. **No plumbing defects or leaks** noted.
- ✓ As noted in the Electrical Section, recommend a licensed electrician repair or replace the faulty **GFCI outlet** in the 2nd floor bathroom.

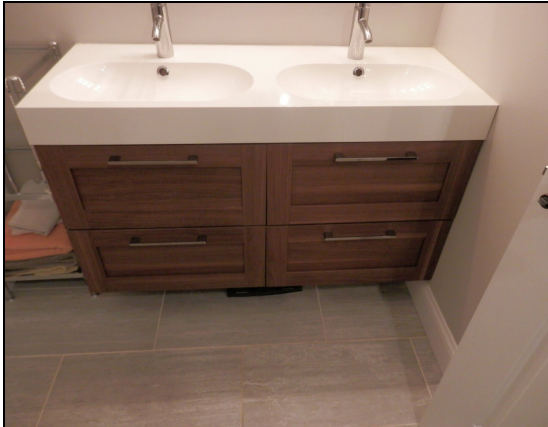
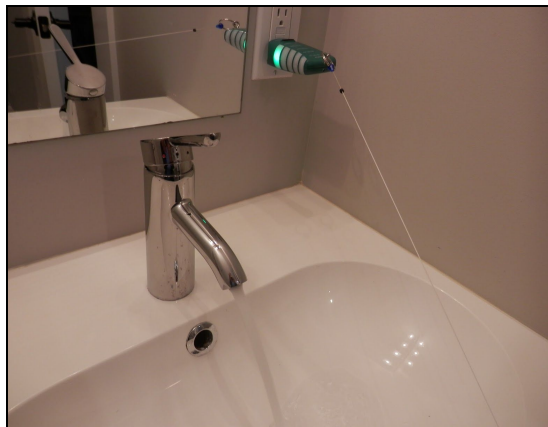
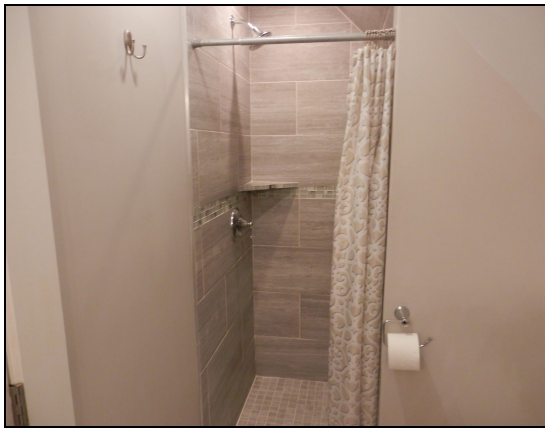
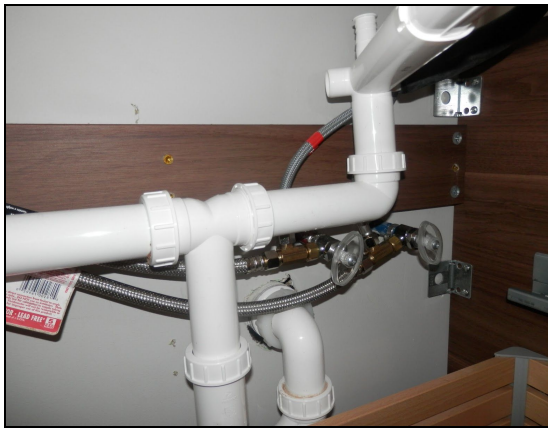
- ☐ The bathroom **walls, ceiling and floor** were in acceptable condition.
- ☐ **No plumbing or electrical defects or leaks** were noted.

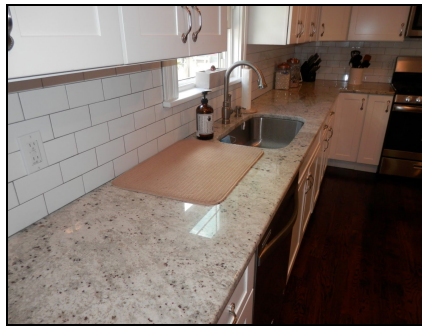
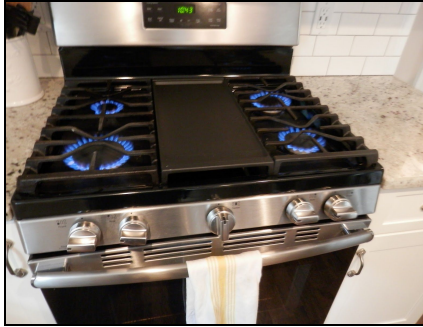
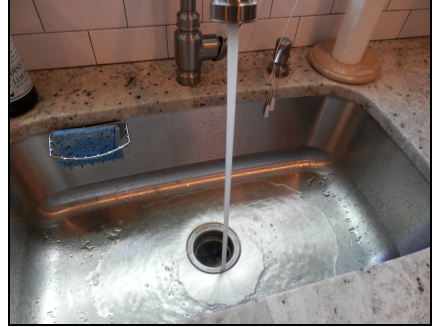
- ☐ The kitchen **walls, ceiling, floor, cabinets and countertops** were in acceptable condition.
- ☐ **Evaluation of appliances** is outside the scope of this inspection. As a courtesy they were turned on and appeared to work as designed.
- ✓ As noted in the Electric Section, recommend repairing or replacing the **faulty GFCI outlet to the left of the sink**.

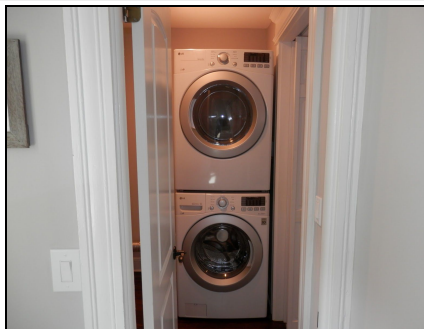
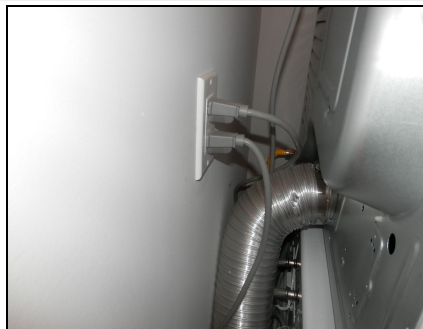
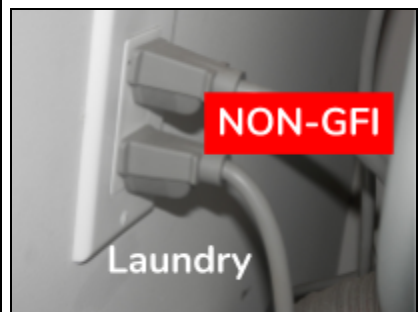
- ☐ **Evaluation of appliances** is outside the scope of this inspection. As a courtesy the washer and dryer were turned on and appeared to work as designed.
- ☐ The **outlet in the laundry** area is regular outlet. This could be a safety hazard if water were to come in contact with the outlet.
- ✓ Recommend replacing the **laundry outlet** with a **GFCI outlet**.

- P.11 Recommend **changing all exterior door locks** upon occupancy.
- P.14 Recommend replacing the **laundry outlet** with a **GFCI outlet.**

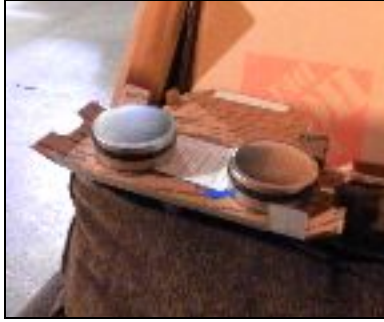
- ❑ **Lab test results:** Radon readings were at levels considered acceptable by the EPA. They averaged **.8 pC/L**, well below the EPA action level of **4 pC/L**.
