Secure Home Inspections of NY, LLC

Client: Mary & John Smith
Address: 1234 Main St
City: Anytown, USA
Phone: 555-555-5555

Inspection Date: 7/14/2020
Inspector: John Mondello
NY Lic #16000055914
jpmondello@gmail.com

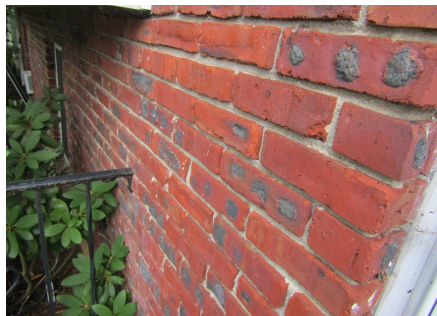
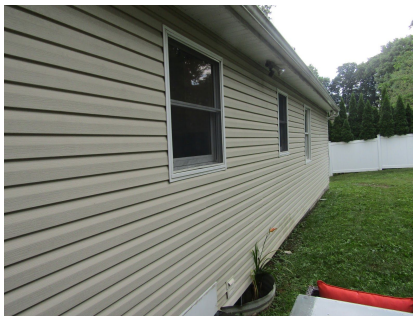
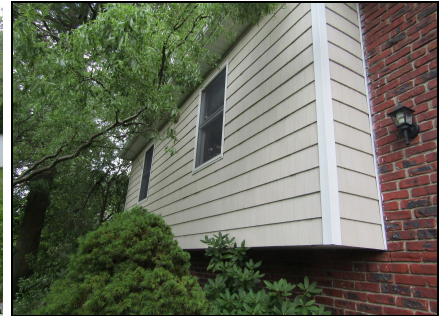
☐ **Brick, cement shingle and aluminum siding** was in serviceable condition.

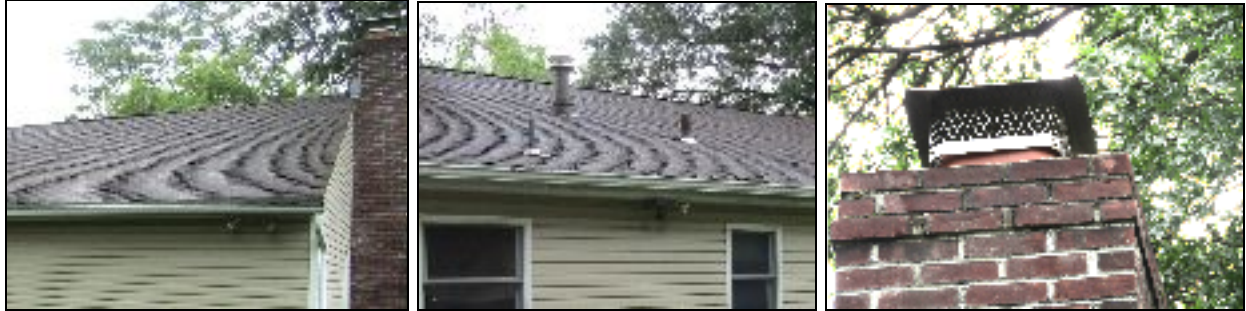
- ☐ **Asphalt roof shingles** appeared to be midlife; roof vent flashing and the brick chimney were in acceptable condition.

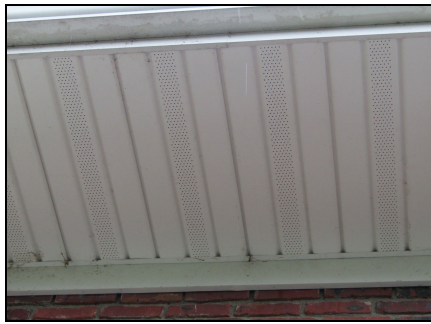
Soffit Vent

- ❑ Soffit, Ridge and Gable vents provided roof ventilation; the house also had an attic gable fan; this link explains how roof and attic [ventilation systems work](#).

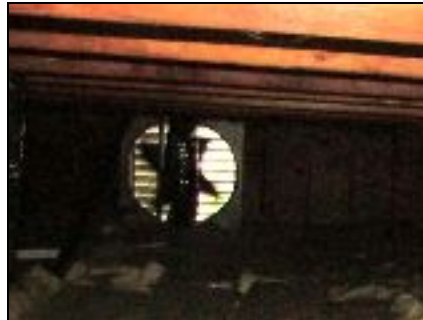
Bathroom Exhaust Vent Pipe

- ❑ Attic rafters and floors and roof decking were in serviceable condition;
- ❑ The [bathroom exhaust vent pipe](#) did not exhaust to the **outside**. This allows **excess moisture** from the bathroom, **especially in the winter**, to build up frost on the underside of the roof sheathing. Eventually this ice melts and **leaks onto the insulation and drywall ceiling**.
- ✓ A qualified person should repair or replace the [bathroom vent pipe](#) so that it vents to the outside.

- P. 5 A qualified person should **trim trees and shrubs back** so that they are not in contact with the **roof, siding, gutters or the shed roof.**
- P. 6 A qualified person should repair or replace the **bathroom vent pipe so that it vents to the outside.**

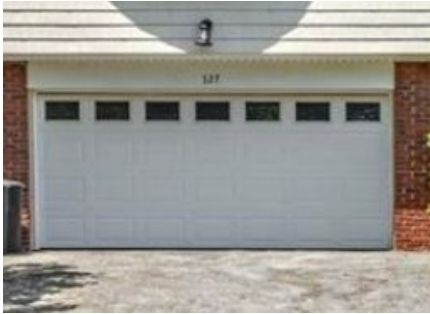
Interior Door

- ✓ The garage roof, walls, ceiling and floor were in acceptable condition. There was no evidence of moisture. The electric garage door was in serviceable condition, except that the garage door **did not auto-reverse when pressure was applied**.
- ✓ The interior garage door to the house **did not self-close**. This could allow car exhaust or flames from a garage fire to enter the house.
- ✓ A qualified person should repair or replace the interior garage door to the house as needed, to make it **self-closing**.

- P. 7 A qualified person should repair or replace the **interior garage door** to the house as needed, to make it **self-closing.**
- P. 8 A licensed electrician should repair or replace the **defective exterior GFCI outlet** on the left side of the house and install a **GFCI outlet in the laundry area.**

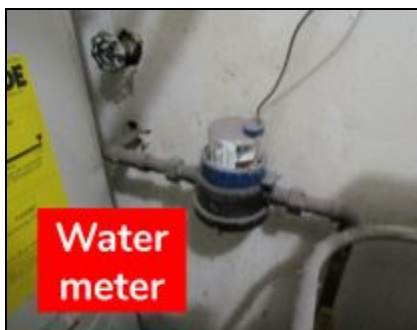
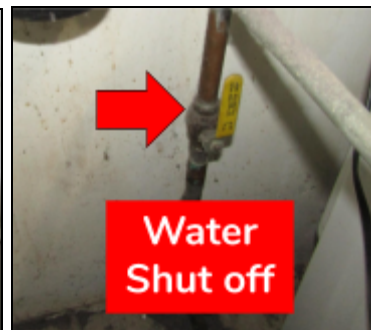
- ☐ All plumbing fixtures were operated and inspected;
- ☐ Ran water in the kitchen and bathrooms for extended periods of time.
- ☐ No visible leaks were detected, except in the Lower Level bathroom (p.14).

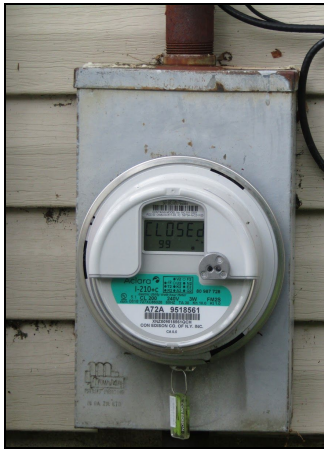
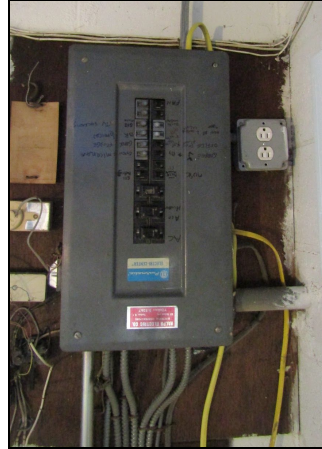
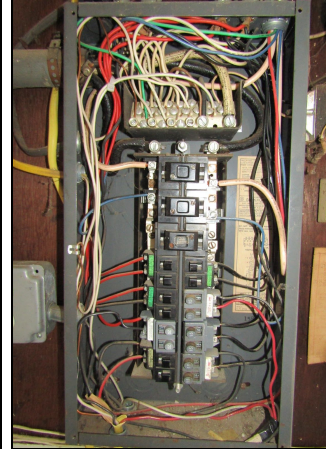
- ☐ The main electrical panel was in serviceable condition.

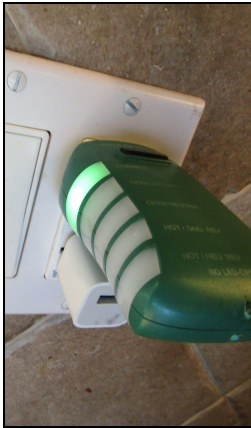
Kitchen GFCI

- ☐ A representative sampling of **standard and GFCI outlets** worked when tested. GFCI outlets protect against electrical shock or fire when connecting appliances that are close to sources of water.
- ☐ The **laundry area was missing GFCI outlets** (pls see the Laundry Section, P. 12).
- ☐ One **exterior GFCI outlet** was defective.
- ✓ A licensed electrician should repair or replace the **defective exterior GFCI outlet** on the left side of the house and install a **GFCI outlet in the laundry area**.

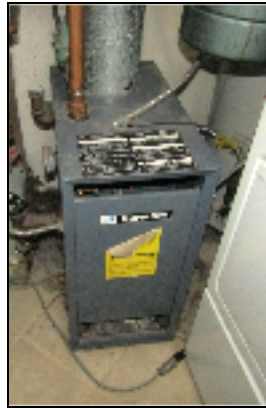
Hot Water Boiler

- ☐ The **gas-fired boiler** supplied hot water to baseboards in **3 zones**: there were separate **thermostats** in the **Living/Dining area, Bedrooms & Lower level**.
- ✓ **Recommend a qualified HVAC contractor clean the boiler, provide instructions on proper care and operation, and set up an annual service program.**

- P. 9 Recommend a qualified HVAC contractor clean **the boiler, provide instructions on proper care and operation, and set up an annual service program..**

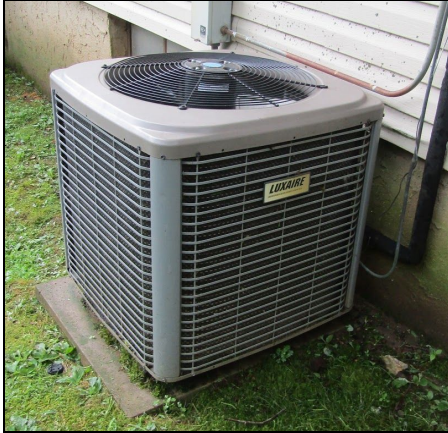
AC Compressor

- ☐ The **split system AC unit** supplied cool air to vents on the **1st floor only**.
- ☐ **Lower Level air conditioning** was supplied by **window units**.
- ☐ **AC air filters** should be [changed regularly](#) - typically bi-monthly. Here is a [guide to AC maintenance](#).
- ✓ A qualified HVAC contractor should **assess the condition of the AC system**, give instructions on its **proper care, operation and filter replacement**, and set up an **annual service program**.

- P. 9 A qualified person should install an **extension pipe to the water heater TPR valve.**
- P.10 A qualified HVAC contractor should **assess the condition of the AC system,** give instructions on its **proper care and filter replacement,** and set up an **annual service program.**

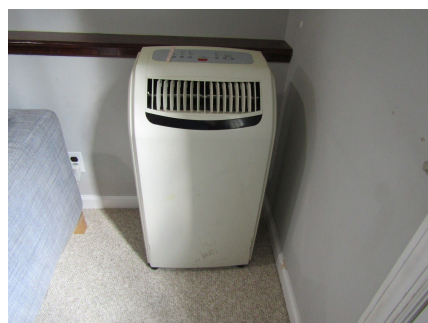
Dehumidifier

- ☐ Floors, walls, ceilings, doors and windows were in serviceable condition.
- ☐ The basement had a **dehumidifier** running. Basement humidity levels **below 50%** can **prevent mold and mildew growth** and improve basement air quality.
- ☐ The **storm drain outside the lower level exterior door was clogged**. This could allow rain water to puddle and enter the house.
- ✓ A qualified person should **clean the storm drain in the stairwell outside the lower level exterior door**.

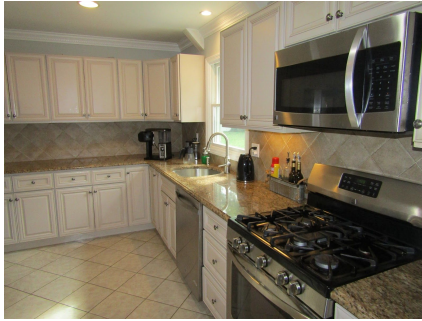
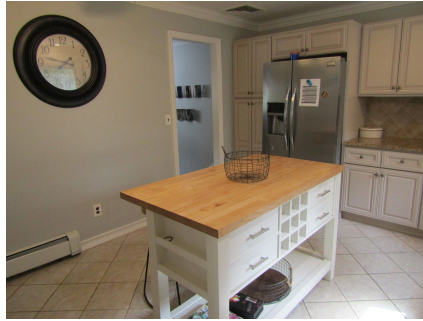
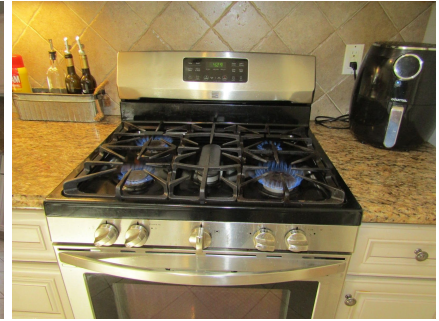
- ☐ There were no leaks or apparent defects in floors, walls, cabinets and countertops.
- ☐ Home Inspectors are not required to observe or report on the **condition of kitchen appliances**. As a courtesy those that were connected were turned on; they operated as designed.

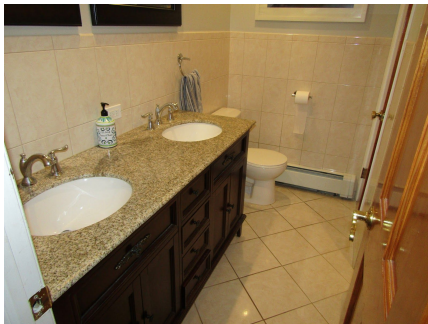
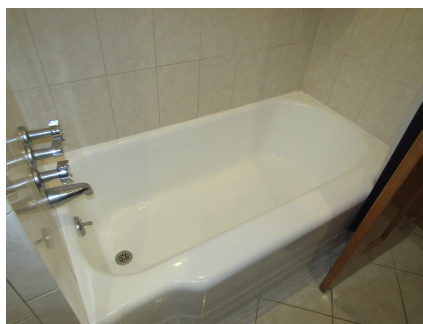
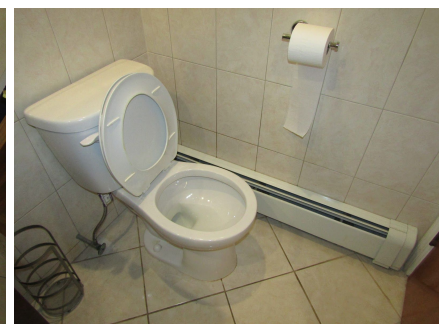
- ☐ There were no defects or leaks in the toilet or sink; water pressure was acceptable.

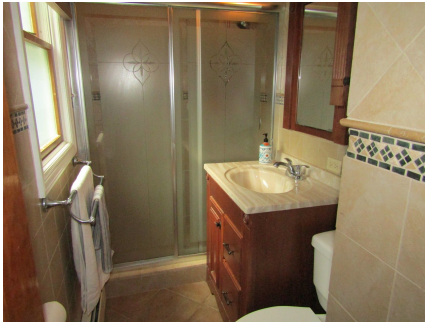
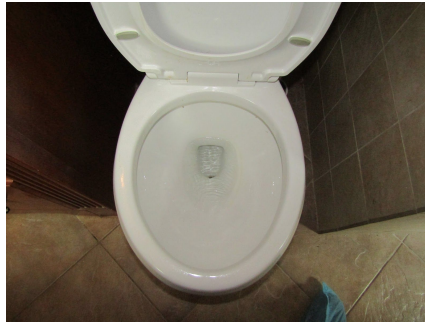
Loose Sink Handle

- ☐ There were no defects or leaks in the toilet or shower; water pressure was acceptable.
- ☐ The cold water **sink faucet handle** was loose or broken.
- ✓ A qualified person should repair or replace the **loose sink faucet handle in the Master bathroom.**

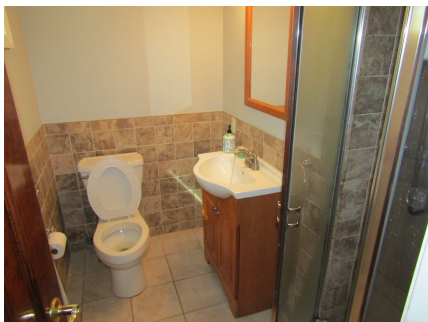
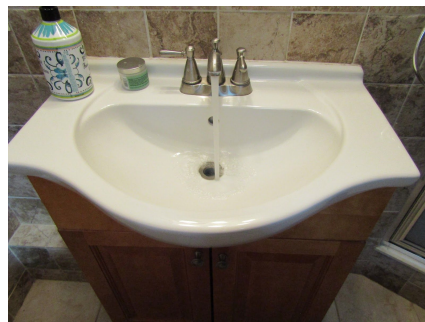
Leaky drain pipe

Ran water and found: Sink drain pipe leak

- ☐ There were no defects or leaks in the **toilet or shower**; **water pressure** was acceptable.
- ☐ The **drain pipe** in the vanity cabinet below the sink **leaked**; a defect.
- ✓ A licensed plumber should repair or replace the **leak in the drain pipe in the lower level bathroom sink.**

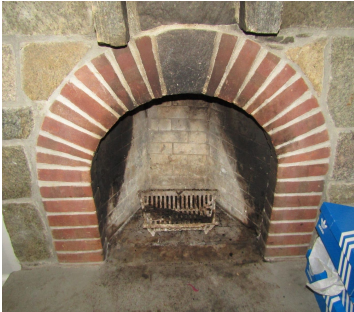
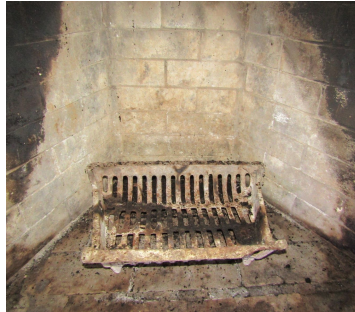
Damper & Flue

Hearth Depth: 18 inches
Hearth Extension Depth: 18 inches
Visible creosote: Minor

- ☐ The damper worked as designed. Creosote buildup was minor.
- ✓ A qualified chimney contractor should conduct a **Level II inspection** and **clean the 1st floor fireplace flue** prior to use.

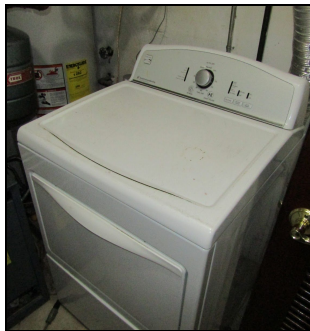
Dryer

- ☐ **Evaluation of washers and dryers** is outside the scope of this inspection. As a courtesy they were turned on and appeared to work as designed.
- ☐ As mentioned in the electrical section, the **outlet in the laundry room** was **non-GFCI**.
- ☐ The **flexible dryer vent** hose had several bends, which could result in lint being trapped. This can affect dryer operation and is a potential fire hazard.
- ✓ A licensed electrician should replace the **laundry outlet** with a **GFCI outlet**.
- ✓ Recommend installing a properly sized **rigid dryer vent pipe**; also advise clearing the **dryer vent pipe** frequently.
