Secure Home Inspections of NY, LLC

Client: J. Smith
123 Main St.
Anytown, NY 10000
(914) 555-5555
info@ny-secure.com

Inspection Date: 3/1/18
Inspector: John Mondello
NY State ID: 16000055914
Report No. 040218-B
jpmondello@outlook.com

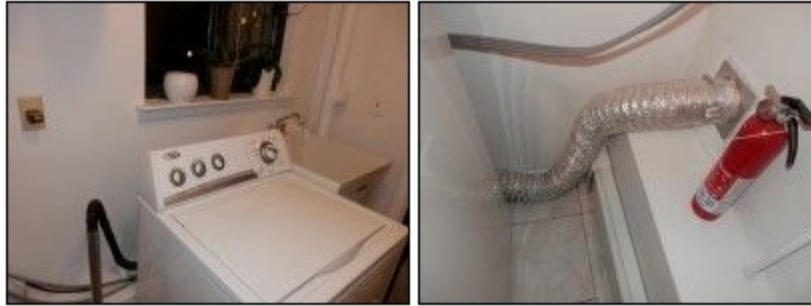
32)

**There were no leaks observed** from the laundry room sink or plumbing on the day of inspection. Evaluation of appliances is outside the Standards of Practice for Home Inspectors. As a courtesy we noted that the appliances did power up. Recommend having your realtor ask if there are any appliance warranties that are transferable.
